# **CULTURAL LANDSCAPE TREATMENT PLAN**

**ROBERT ALLERTON PARK**

**Cultural Landscape Treatment Plan**  
Robert Allerton Park  
Monticello, Illinois

September 2001

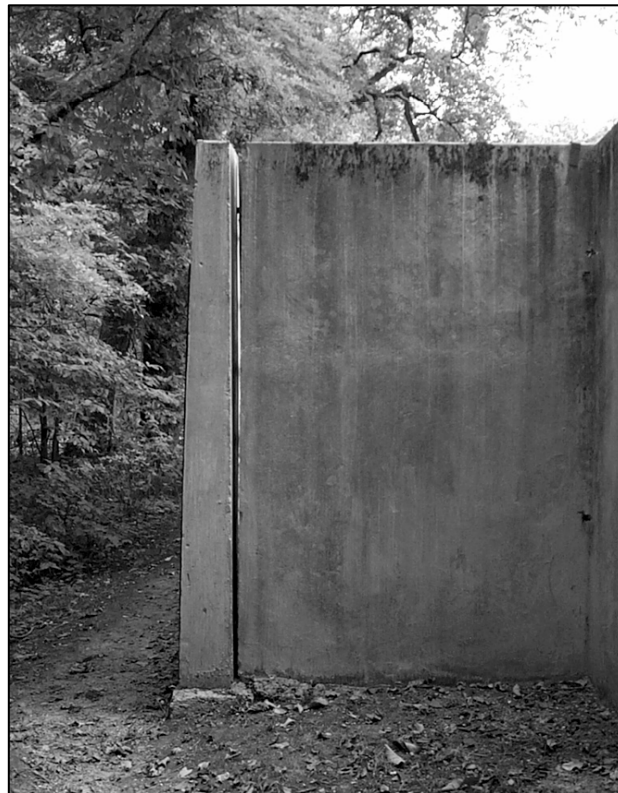
**2001** – Some sections of the Sunken Garden wall, such as this area where two sections have separated, require structural stabilization. There are also issues associated with surface treatment and minor losses.

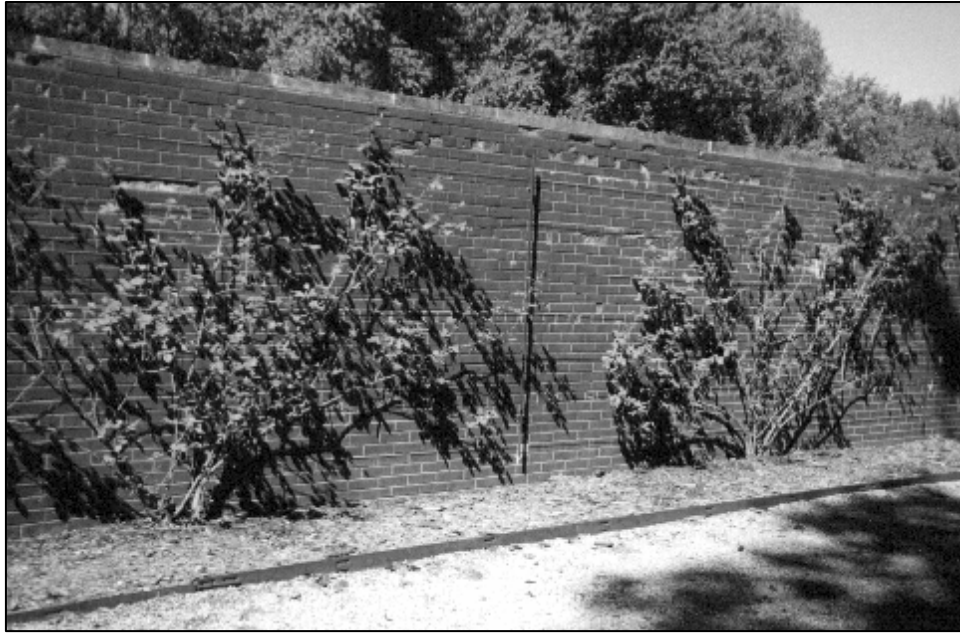
**2001** – The brick walls surrounding the Brick Wall Garden (seen here from the Square Parterre Garden) must be repaired prior to any rehabilitation of plantings. The spalling evident in this photo may be due to problems with an improper capstone.

- Repair Brick Perimeter Walls (Brick Wall Garden, 3A)
- Restore arch in Stair Tower and Remove Foundation (5E &G)
- Repair Concrete Walls (Flower Gardens, 6A and Chinese Maze Garden, 7B)
- Repair Concrete Walls, Pylons and Lattice (Sunken Garden, 9A, 9B)
- Repair Brick Columns, Repair/Reconstruct Trellising (Vine Walk, 12E, and elsewhere)
- Rehab House of Golden Buddhas (Vine Walk, 12A)
- Reconstruct Stair Towers (Chinese Maze Garden, 7E)
- Remove post 1946 foundation (Triangle Parterre, 5K)

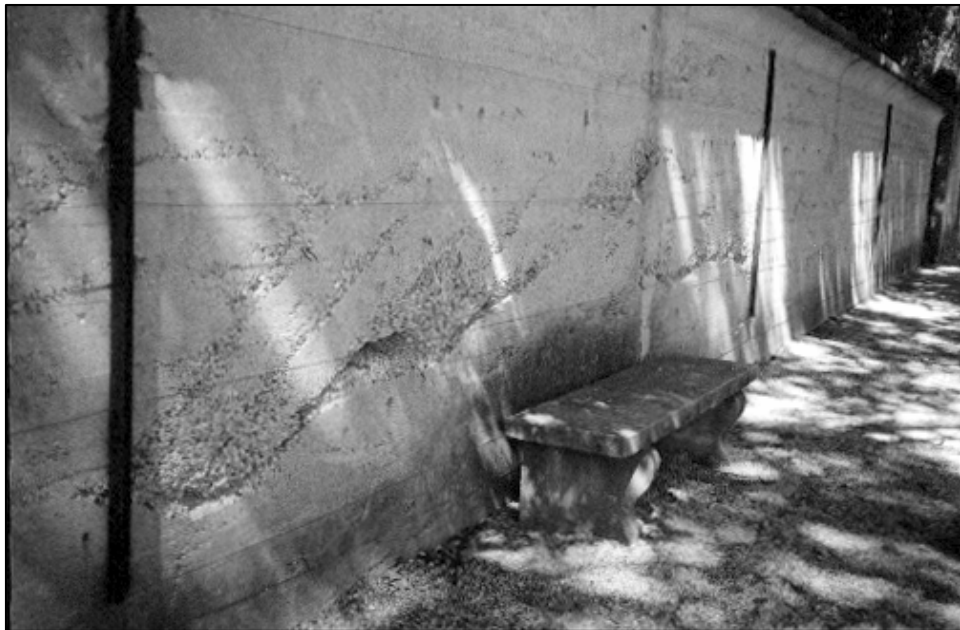
**2001** – The rough texture of the concrete walls is an inherent characteristic of their construction, but when losses have increased to a point where they threaten the structural stability of the wall, they must be repaired.

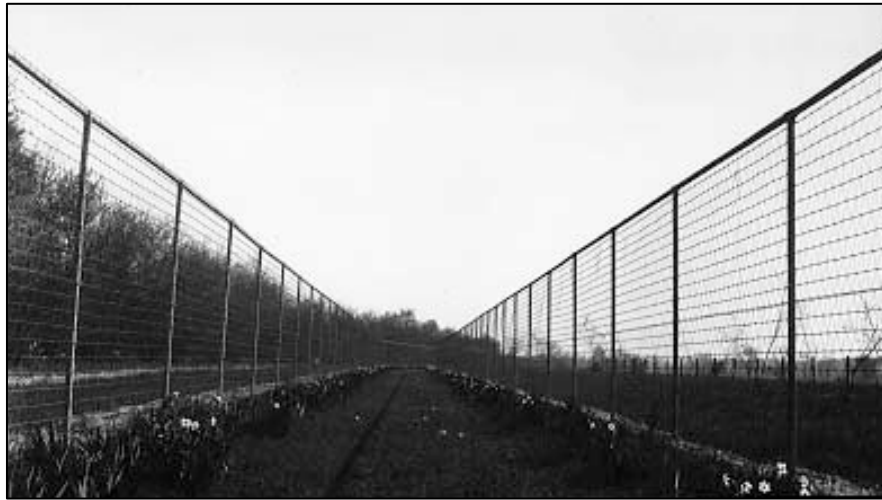
1918 (HGFD-1) – This early view shows the structure of the Vine Walk trellis before planting.

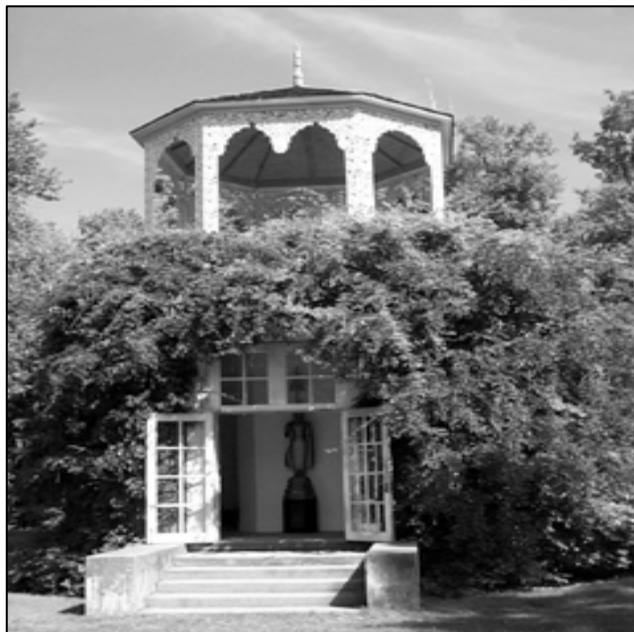
2001 – The House of the Golden Buddhas is a focal feature that is in need of careful rehabilitation. This is a discreet project that could be undertaken independently of other work. The first step should be preparation of a Historic Structures Report.

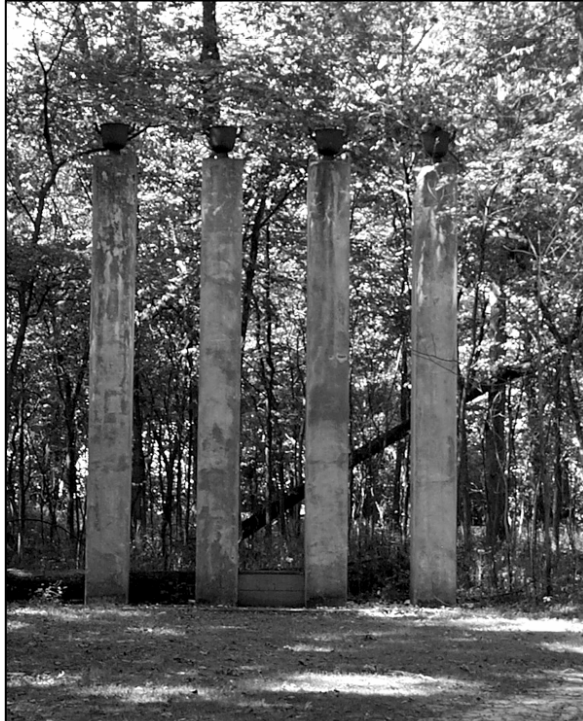
**2001** – Pylons associated with the outlying spaces of the Centaur indicate serious deterioration, including evidence of recent losses. This hazardous condition should be rectified as soon as possible

- Repair/Replace Pylons (Centaur, 10A) - High priority, potential safety hazard.

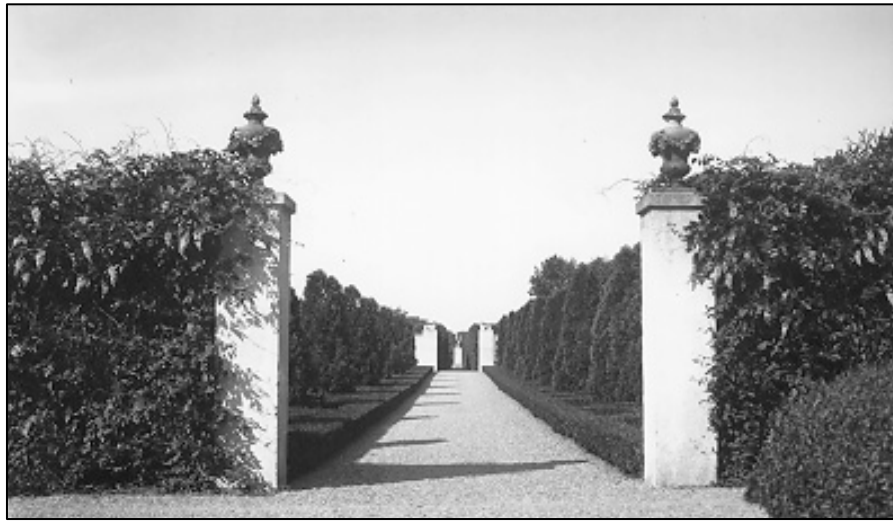
**1930 (HGTO-6)** This view of the Triangle Parterre Garden shows plantings in scale with the space.

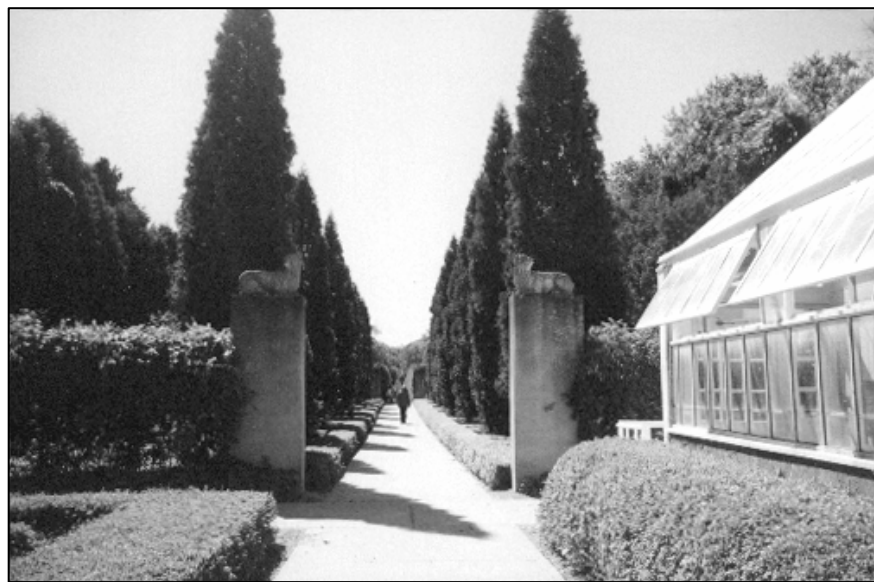
**2001** – This current view shows arborvitae that have grown out of scale.

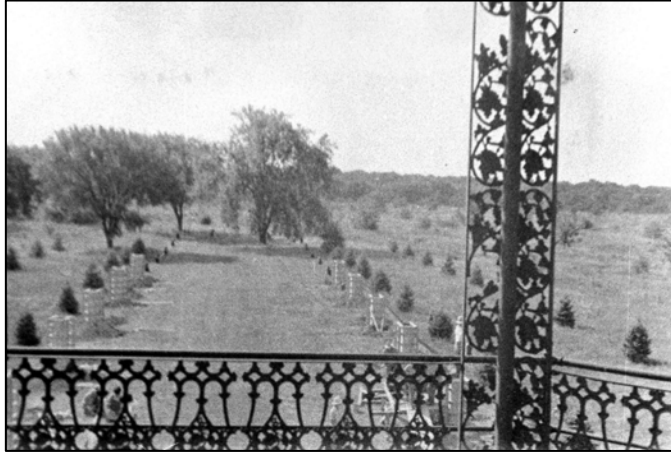
**1932 (HGFC – 1)** Firs were initially planted to define the space.

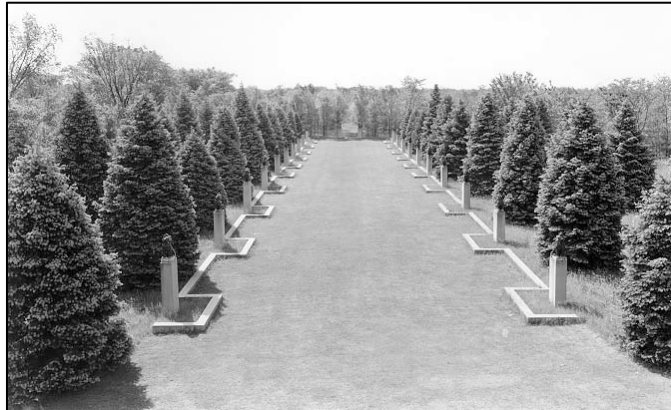
**1944 (HGFC-8)** Firs have reached intended size and shape.

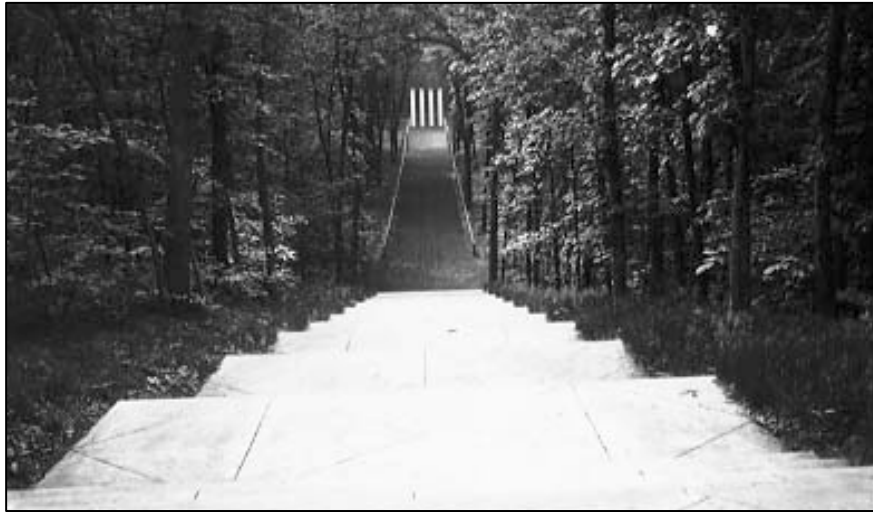
**1935-40 (HGCN-17)** – In this early view from the *Centaur*, the pylons are a visible and integral component of the landscape setting.

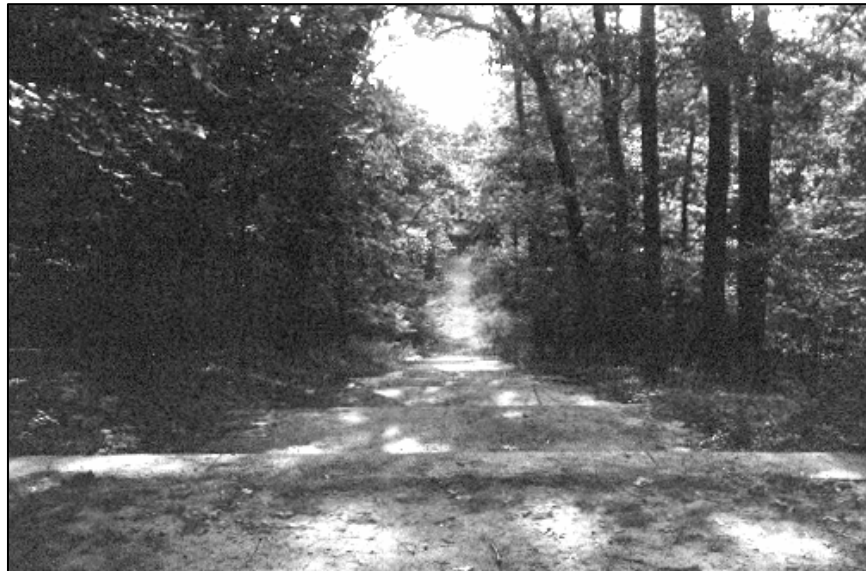
**2001** – Today the pylons are all but lost from view.

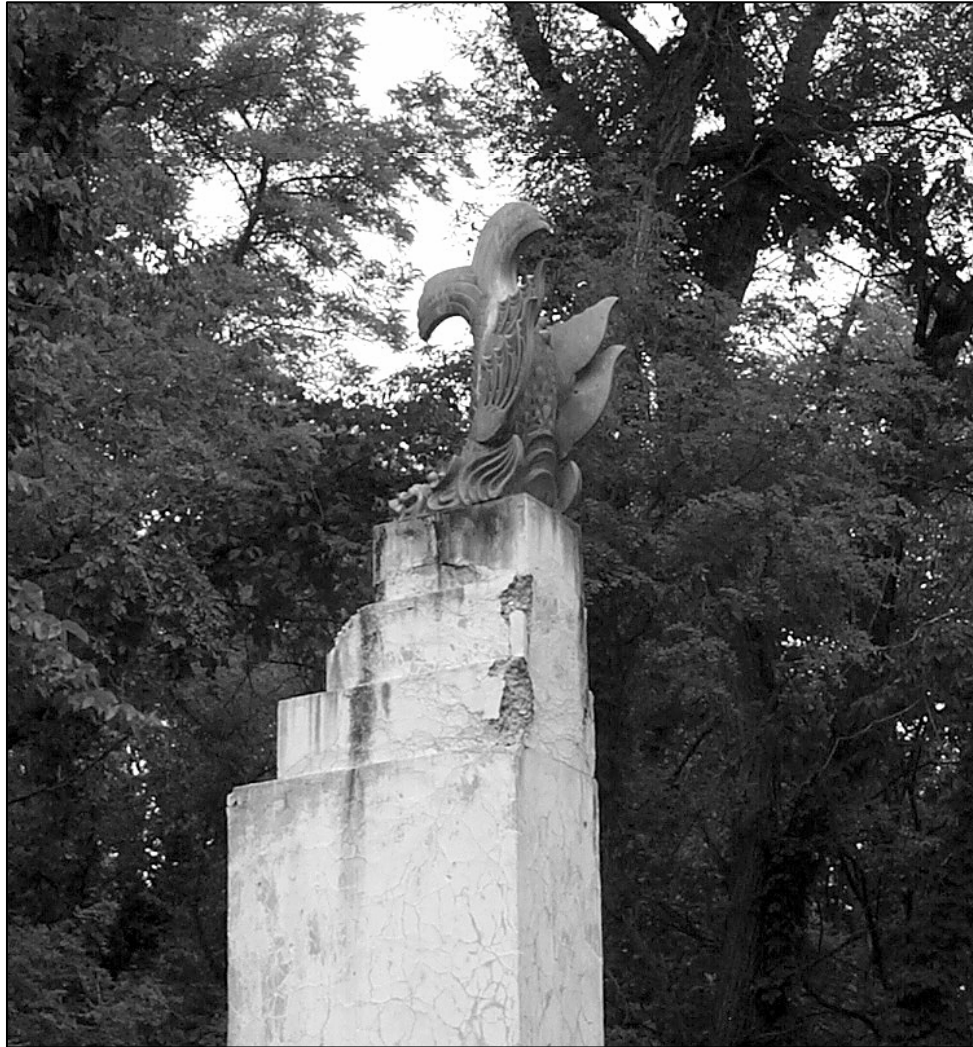
**2001** – The Japanese Guardian Fish at the Sunken Garden illustrate the difficulty of preserving fragile works of art in a wooded setting. They have lost their gilding and are threatened by overhanging trees.

- Sea Maidens/Columns (2D)
- Replace/Conserve Chinese Goldfish (7D)
- Japanese Guardian Fish (9C)
- Chinese Goldfish and Benches (9D)
- Swedish Cauldrons (10B)
- Sun Singer, including pedestal and base (11A)
- Siamese Buddhas and Hari-Hara (12B)
- Fu Dogs (13A)

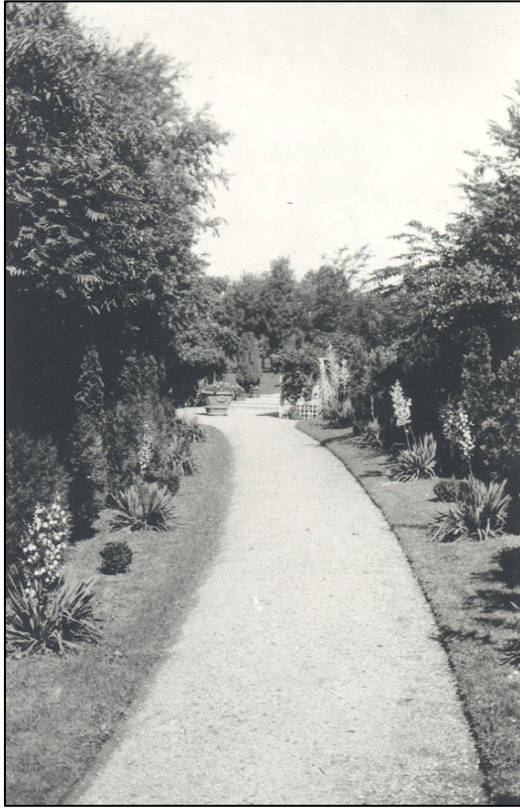
**1908 (HGAF-4)** Early view looking northwest along southern section of path developed in 1902 to connect house to formal gardens. Path was initially narrower than it is today and was lined with Irish juniper, yucca and other herbaceous plant materials.

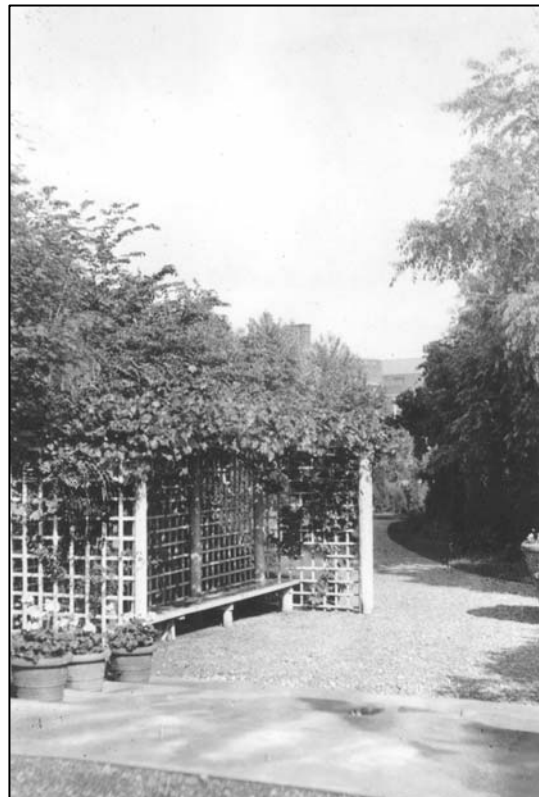
**1908 (HGAF-8)** Two wooden arbors were located near the steps at the middle of the path until 1910.

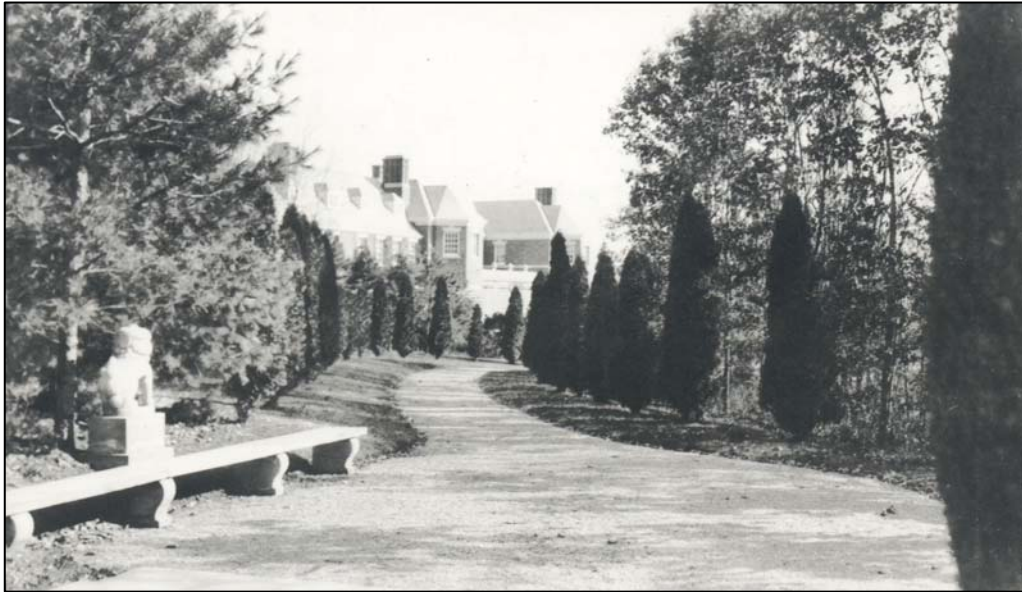
**1915 (HGAF-17)** The plantings along the path were simplified by 1915, with herbaceous materials and arbors removed. Concrete benches with Korean Fu Dogs behind them replaced the arbors. Junipers and grass continued to line the path along its entire distance, as shown in this view of the southern section looking towards the house.

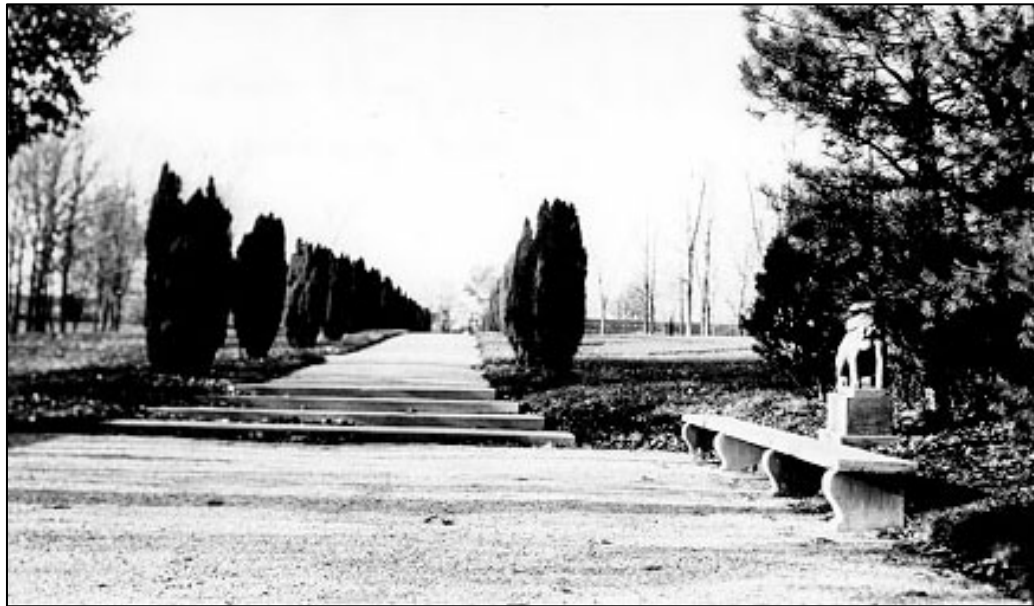
**1915 (HGAF-18)** This view towards the Rose Terrace shows the northern section of the path, which was more open with turf behind the junipers.

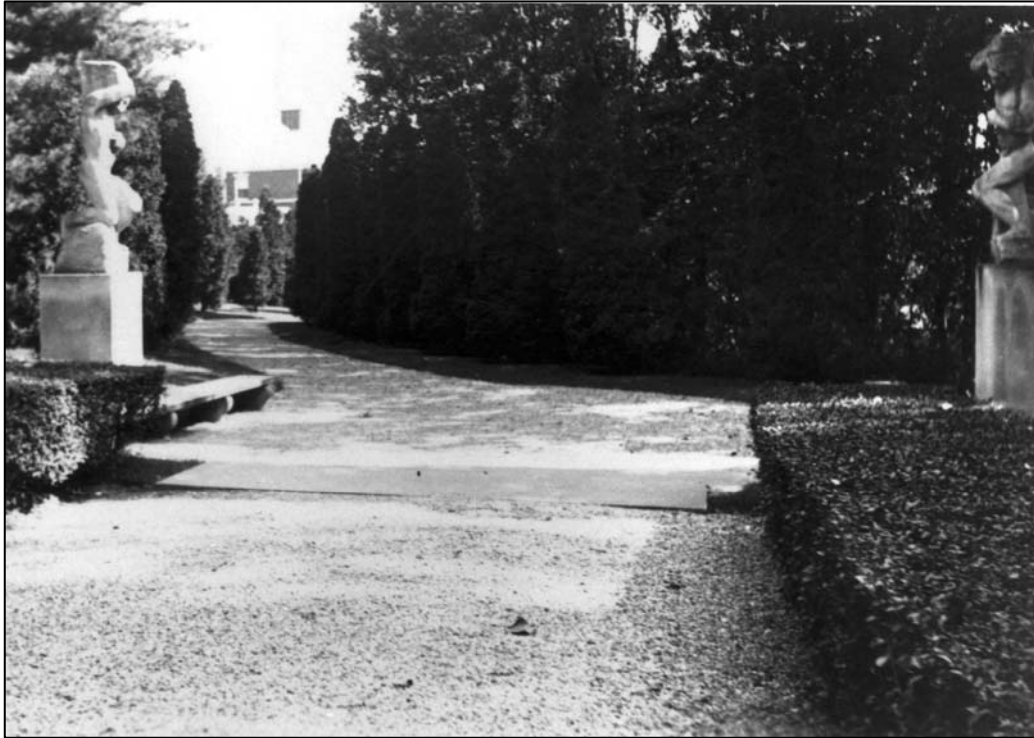
**1925 (HGAF-27)** By 1917 there was a low privet hedge along the northern section of the path (visible in foreground). In 1922 the *Primitive Men* (shown here) replaced the Fu Dogs.

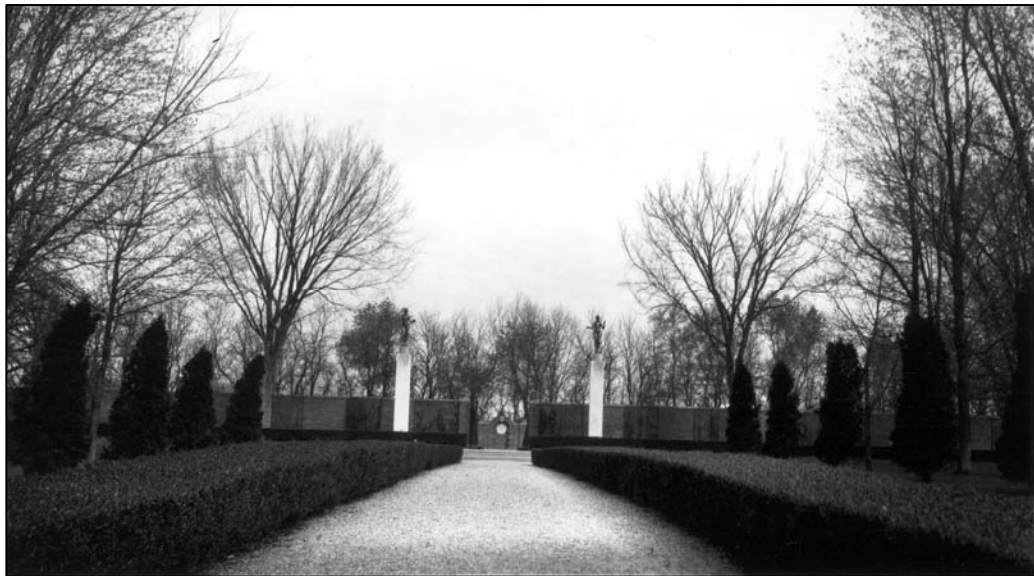
**1940 (HGR-33)** By this time the forest had grown up on either side of the path. In this view along the northern section towards the Rose Terrace, the low hedge is the primary space-defining feature. The upright juniper was replaced with arborvitae and later with yews

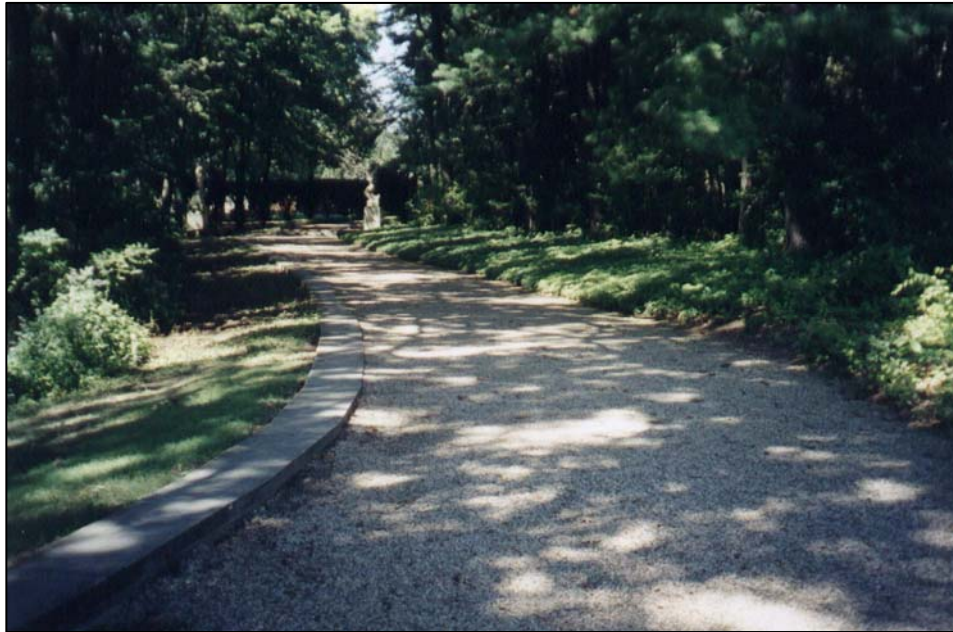
**2001** – View looking north away from house. This area has become shady over time, necessitating an adaptation in the plantings. Low curb on left side of path is a post-1946 addition that prevents erosion.

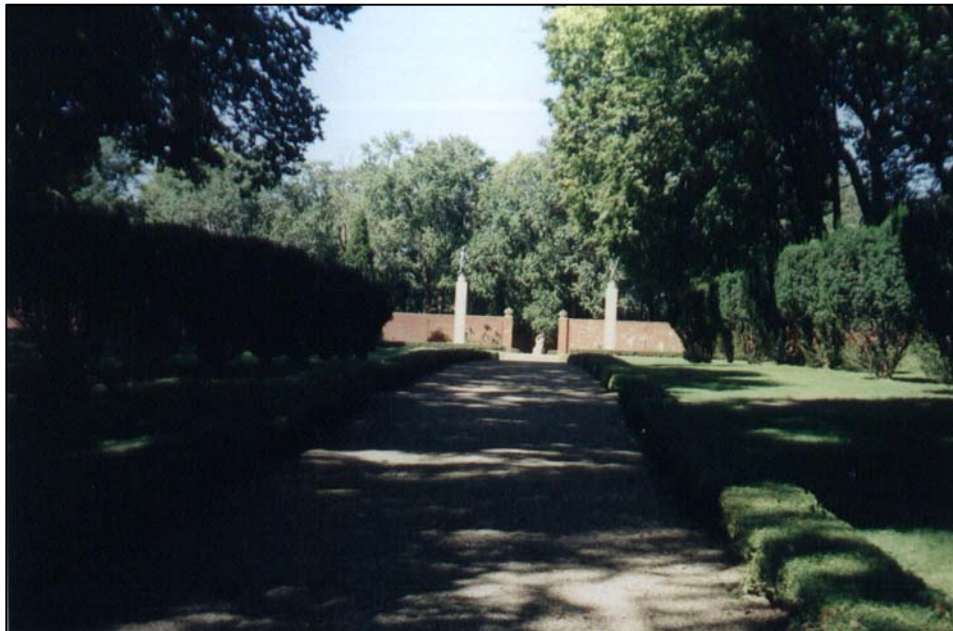
**2001** – View north towards Brick Wall Garden. Compare with 1940 view on previous page, where the arborvitae lining the path provide a very different vegetative character than the current yews.

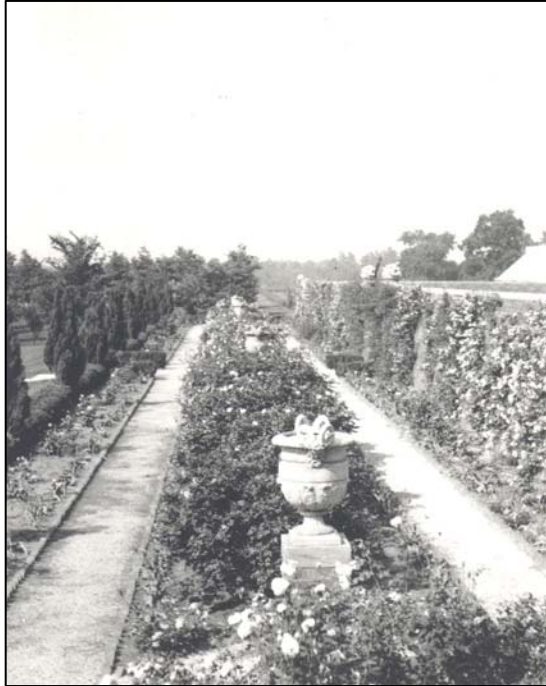
1908 (HGR-7) Early view showing heavily planted rose terrace with espalier on walls and dual path system with brick edging.

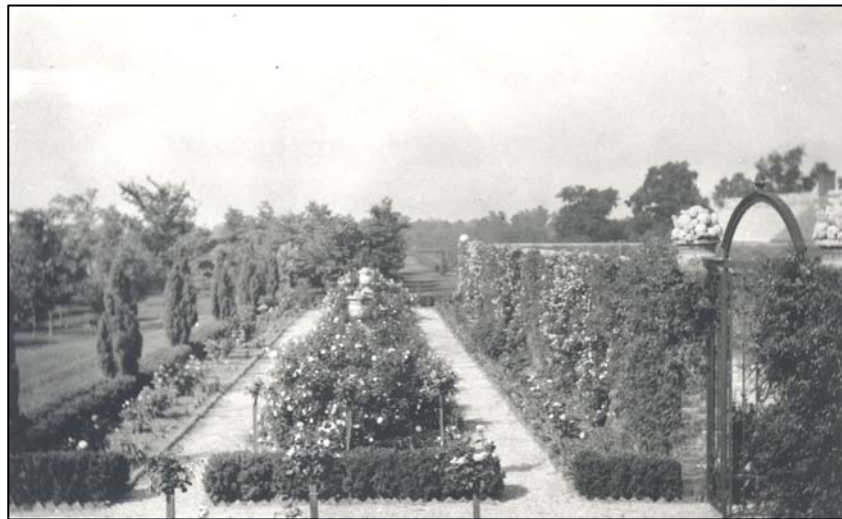
1908 (HGR-11) This view shows the low hedges and fastigate Irish juniper that define the edges of the space. The Borie gates, which were here until 1930, are visible on the far right.

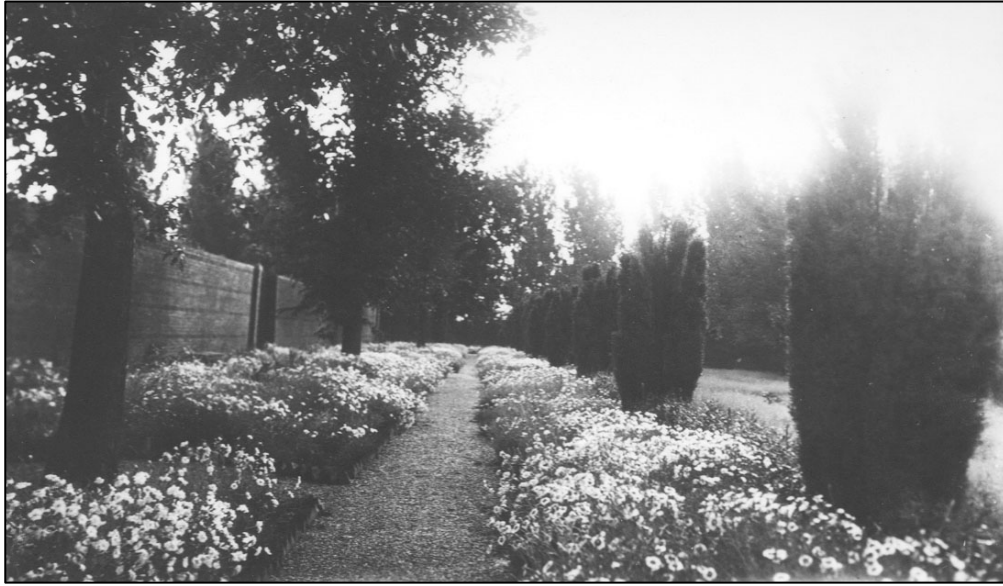
**1920 (HGR-14)** By 1920 the elms in the center beds were well established and the roses had been replaced by more shade tolerant flowers.

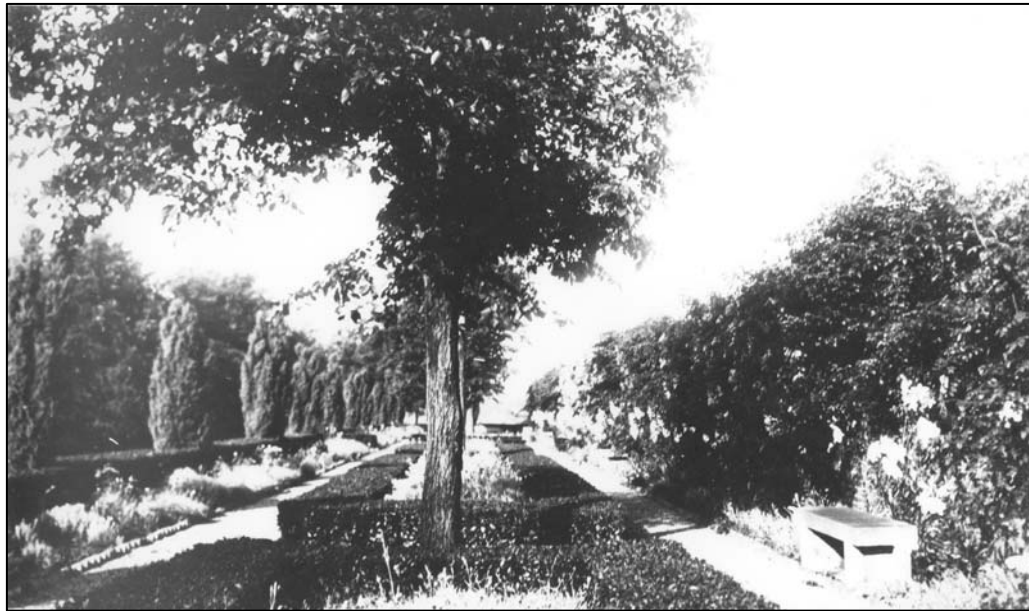
**Early 1920s (HGR-17)** The formal hedge-enclosed beds are retained in this view, but the roses have been replaced by other perennials.

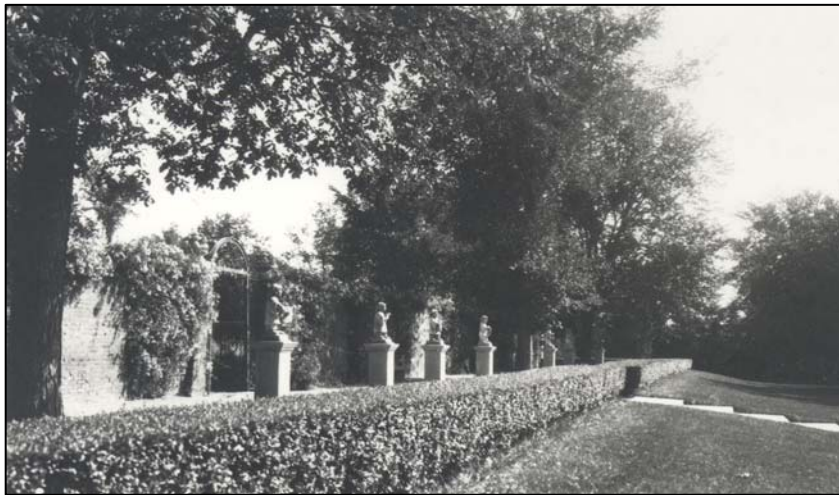
**1925 (HGR-20)** View from outside the garden showing steps and perimeter

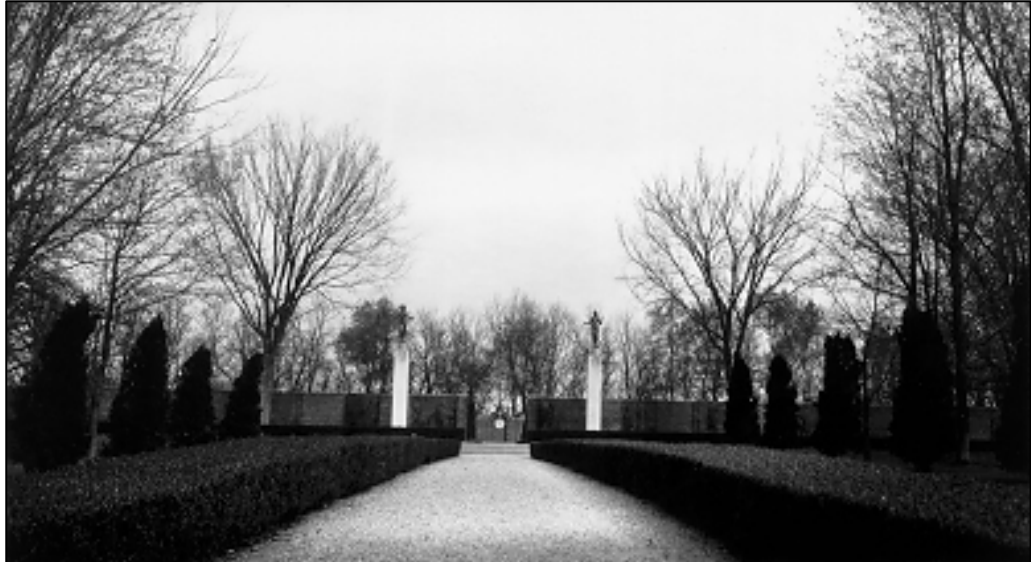
**1940 (HGR-33)** The *Chinese Musicians* were relocated to the Lost Garden in 1932. The *Sea Maidens* (shown here on either side of the gates) were placed on high columns at the entrance to the Brick Wall Garden in 1935.

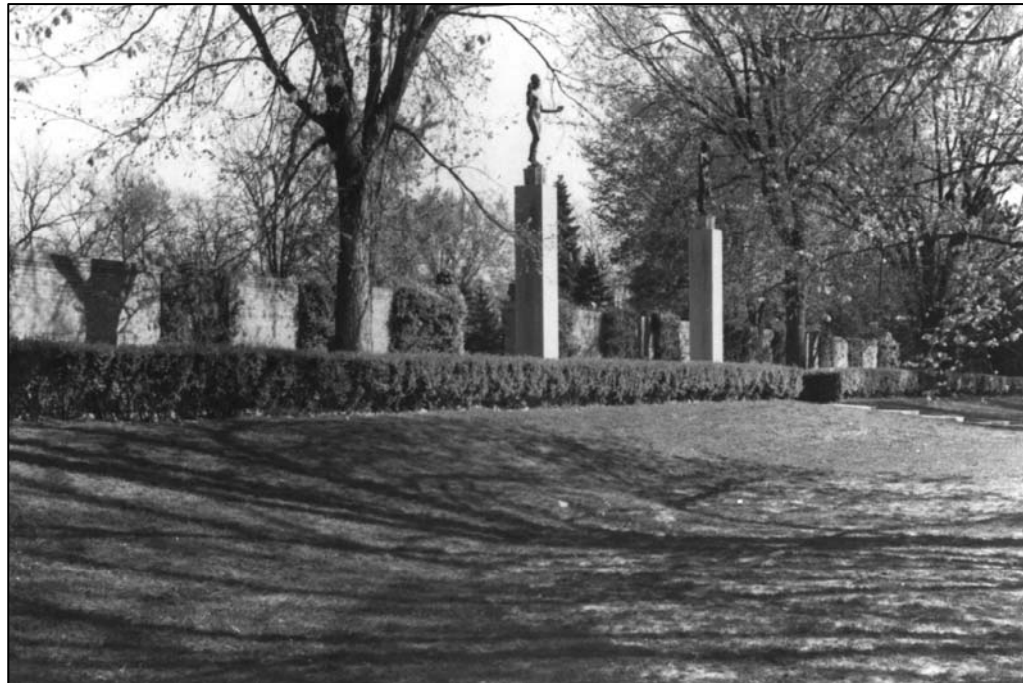
**1945 (HGR-35)** Key features of the garden during this period were the *Sea Maidens*, the elms, and honeysuckle on the brick walls, the privet hedge and the gravel path. It had become a shady garden with less detail than the rose garden

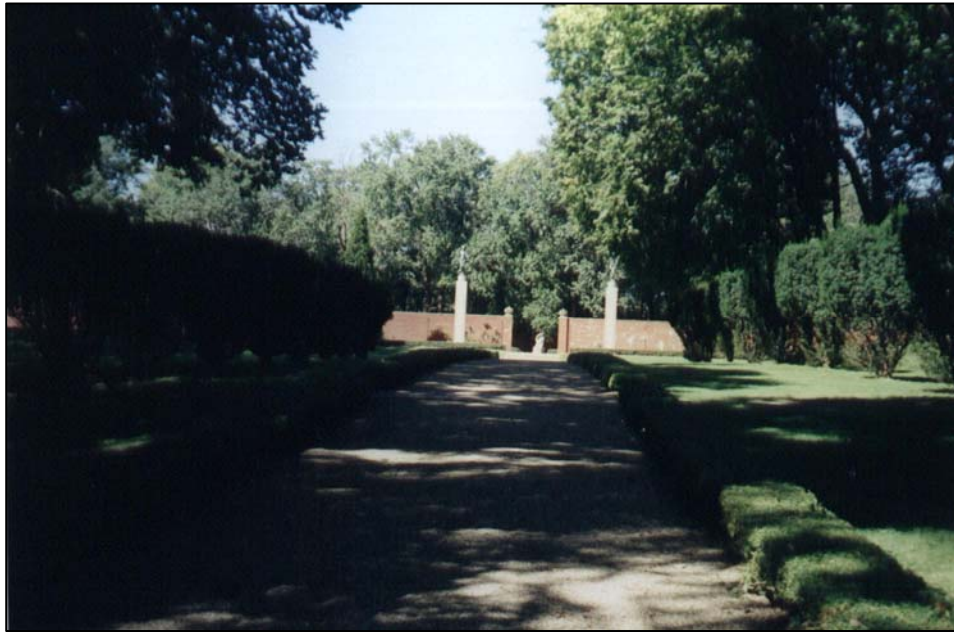
**2001** – Compare this current image with that on the previous page taken in 1940. Surrounding vegetation has grown in, particularly on the right, blocking the view of the *Sea Maidens*.

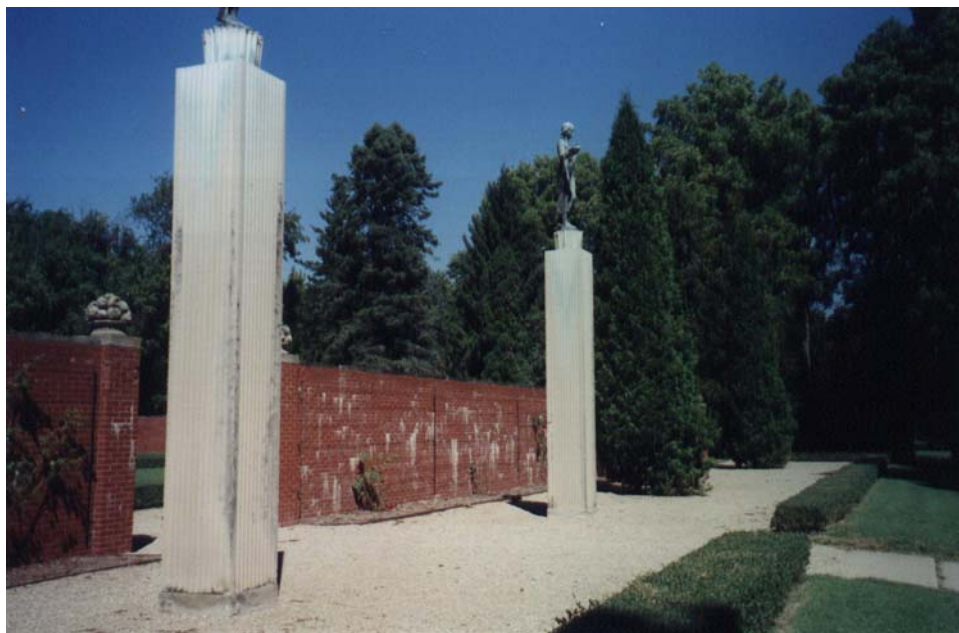
**2001** – John Gregg Allerton’s intended planting of American elms to accompany the *Sea Maidens* has been replaced by arborvitae, which does not create the same effect. Compare with 1945 view on previous page.

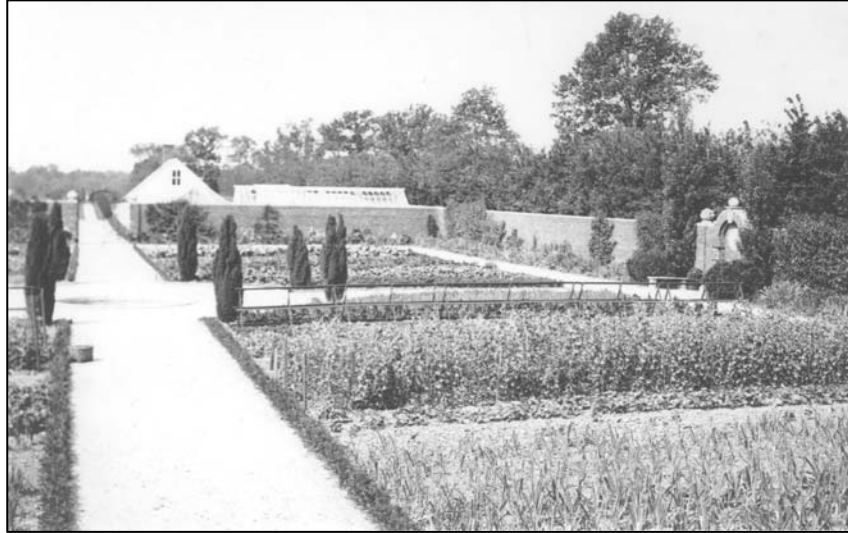
1908 (HGW-5) Vegetables were planted in rows with carrots used along the central path as edging. Eight Irish junipers provided a vertical accent at the center of the garden.

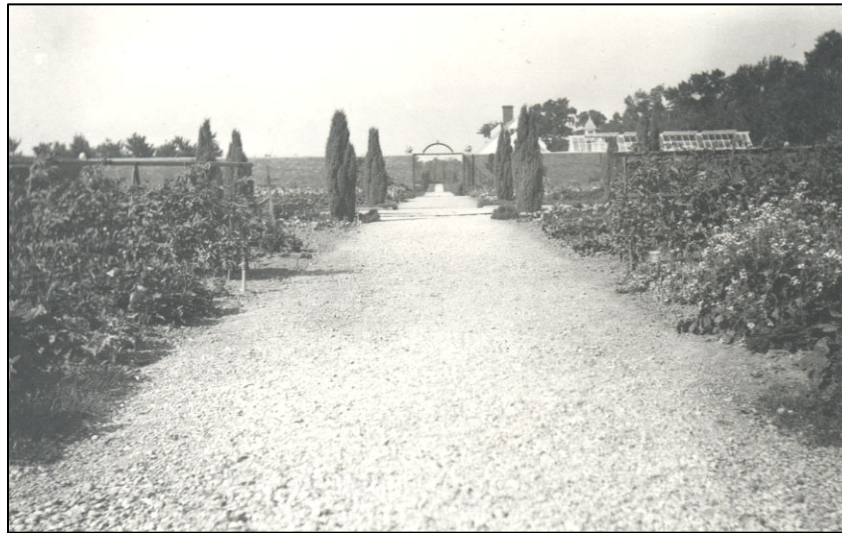
1909 (HGW-21) This garden began as a simple vegetable garden enclosed by a brick wall on three sides. View looking west towards the greenhouse with Borie gates in the

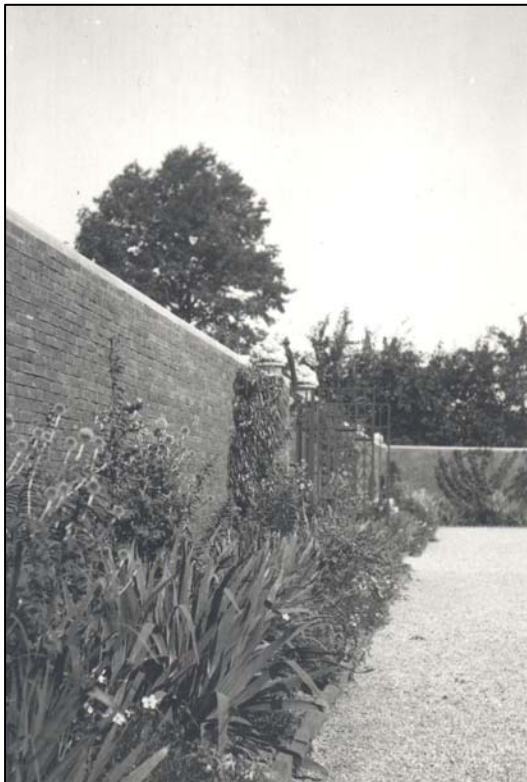
1914 (HGW-18) Detail of perimeter planting.

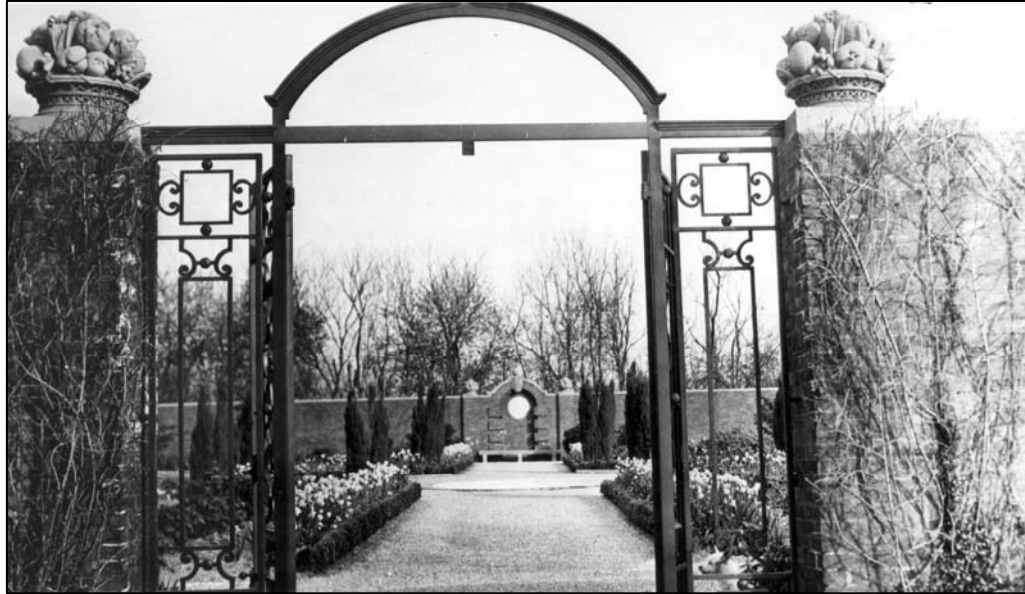
1915 (HGW-23) Borie gates (in foreground) were here from 1905 to 1930. Plantings along paths had become more decorative by this time.

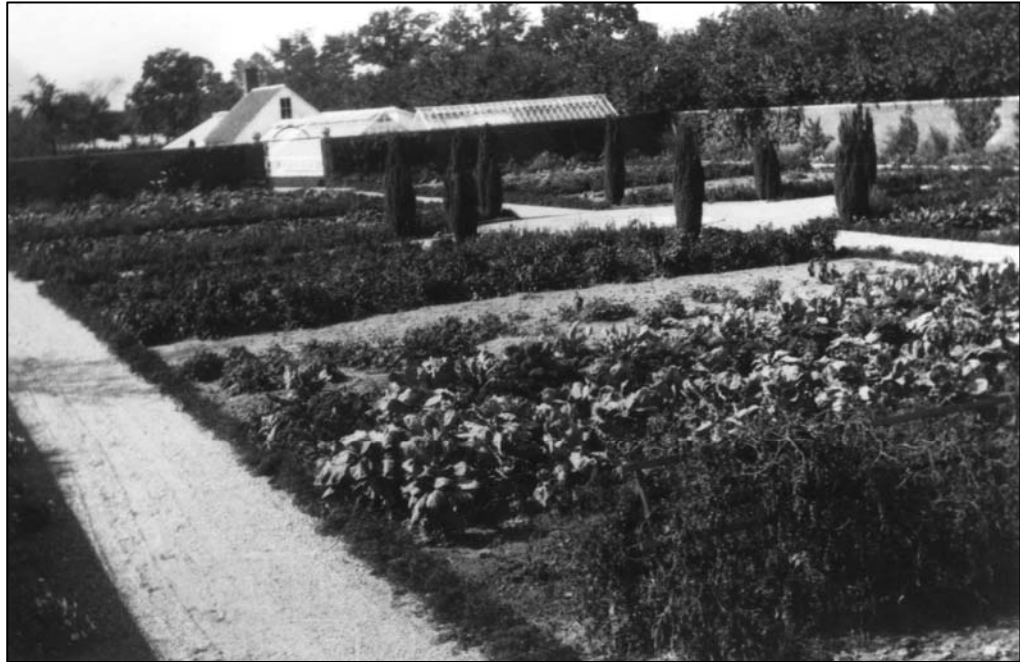
(HGW-33) The carrot border was replaced by privet in the 1920s. The garden was used for vegetables until the early 1940s.

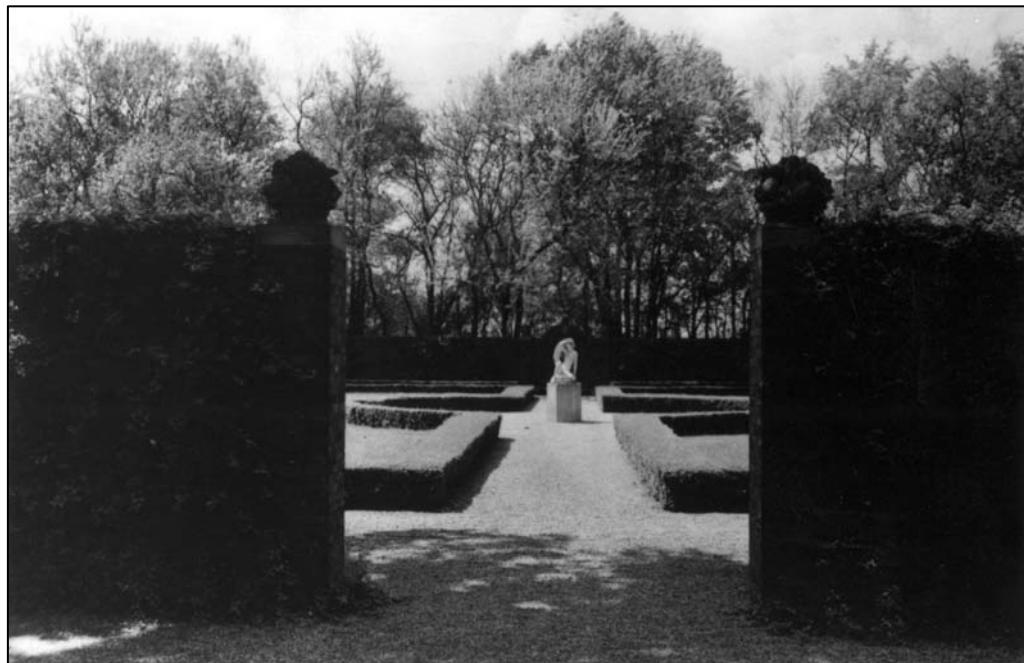
1944 (HGW-45) The *Girl with Scarf* was installed in 1942. Around the same time, the vegetable beds were replaced with turf, similar to what exists today. The Borie gates were relocated to the Chinese Maze Garden in 1930.

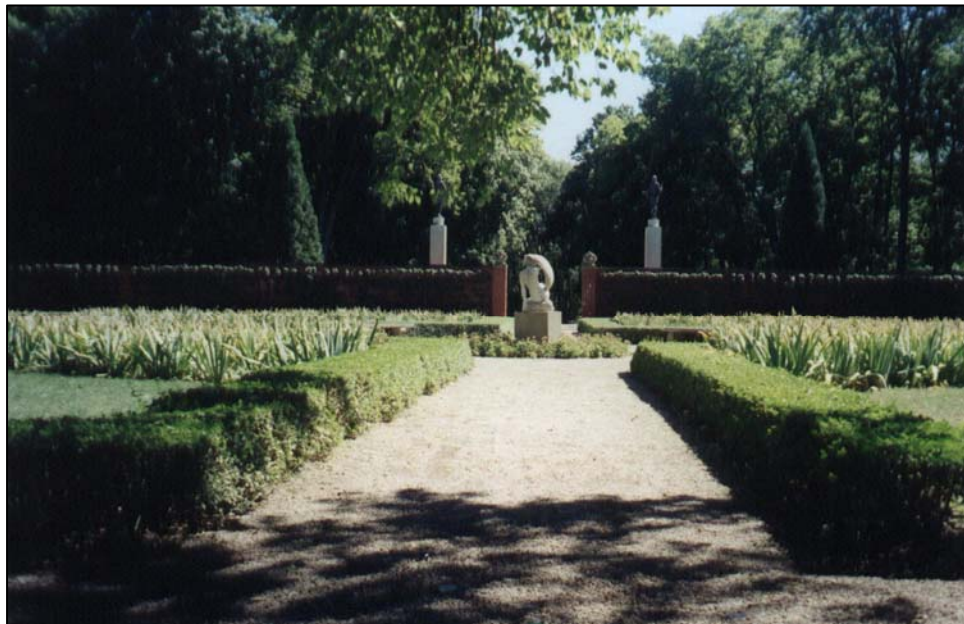
**2001** – This recent view is similar to one taken in 1944 (see previous page) except that ornamental plantings have been added around the central sculpture

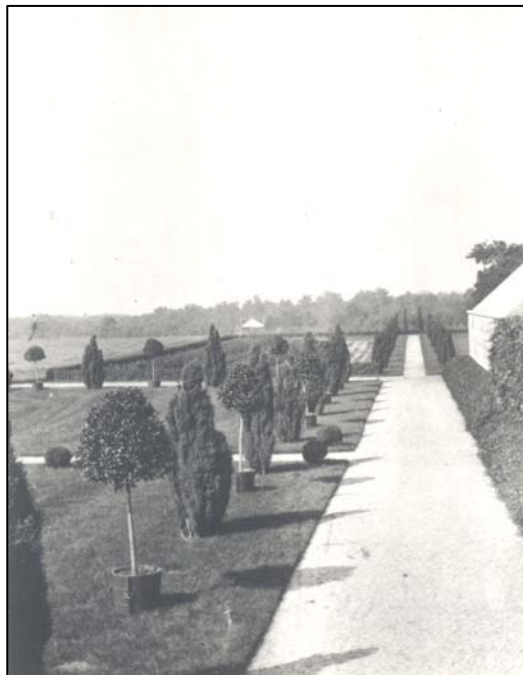
**1908 (HGHS-3)** This view from the east shows the wide east-west path and greenhouse with low hedge in front, features which have remained largely constant since 1908. The garden itself was not yet established in its present form but instead consisted of alternating fastigiata evergreens, potted topiary and low mound-like plants. Note early view of Triangle Parterre Garden in the background.

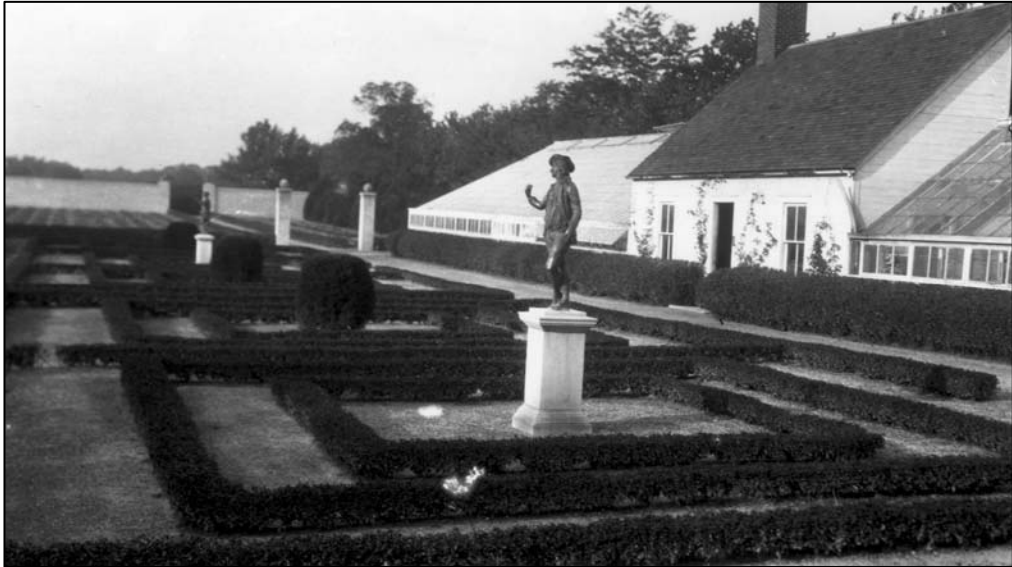
**1918 (HGHS-10)** By this date the six square parterres were in place. Hedges were much lower and narrower than they are today. Some squares have an opening at the north side of the outer square, which no longer exists. Sculptures of a shepherd and shepherdess are in second and fifth squares, with mound-like evergreens in center of
