# **CULTURAL LANDSCAPE TREATMENT PLAN**

**ROBERT ALLERTON PARK**

**Cultural Landscape Treatment Plan**  
Robert Allerton Park  
Monticello, Illinois

September 2001

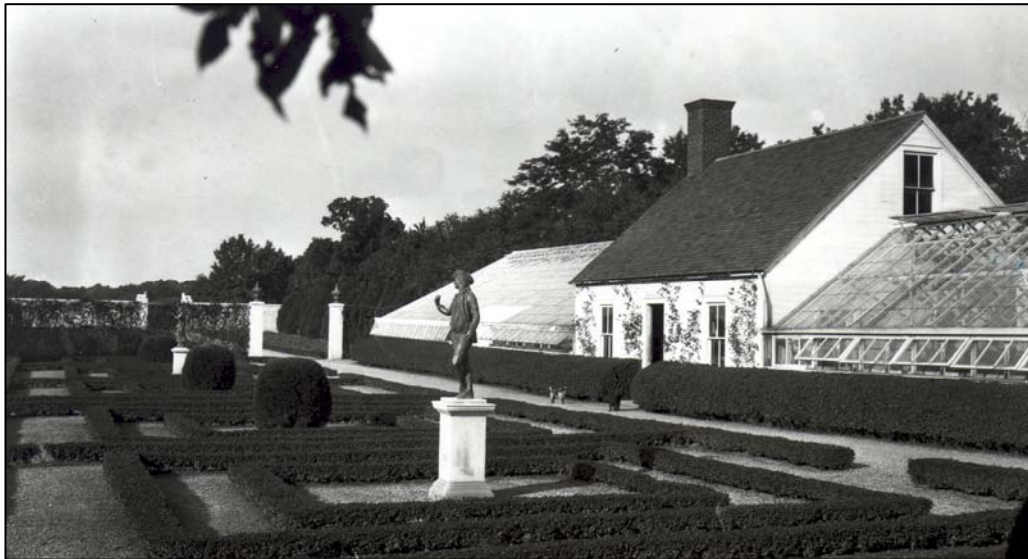
**1920 (HGHS-14)** This view is similar to the one taken two years earlier except that it shows the vine trellis along the eastern wall of the triangle parterre garden.

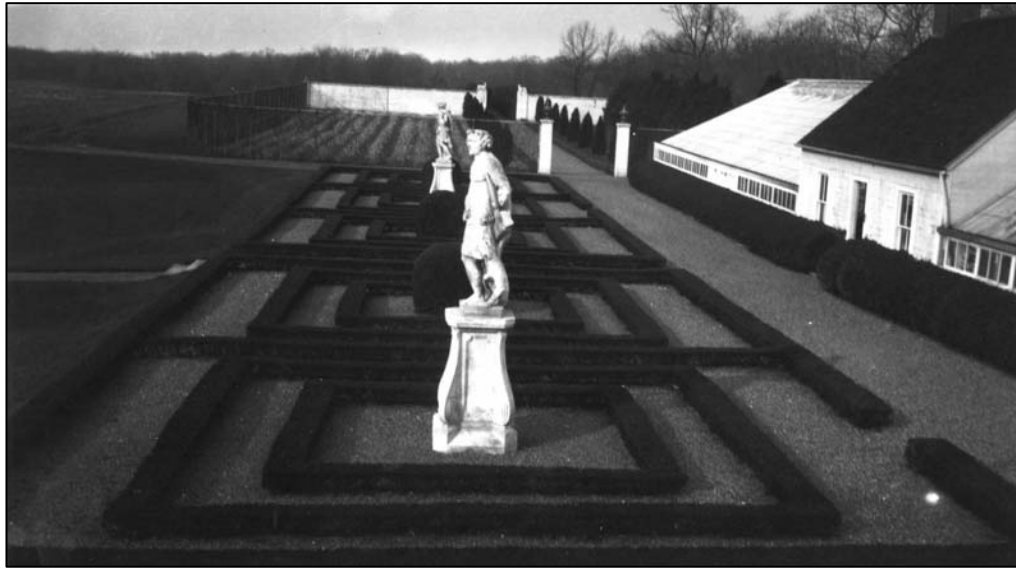
**1925 (HGHS-18)** The major change in this 1925 view is that *Diana* and an *Ephebe* have replaced the shepherd and shepherdess. There are new, more elaborate sculpture bases too. Note the central path and steps at far left, also the path leading to the meadow at the far end of the garden. By this time there is clearly gravel between

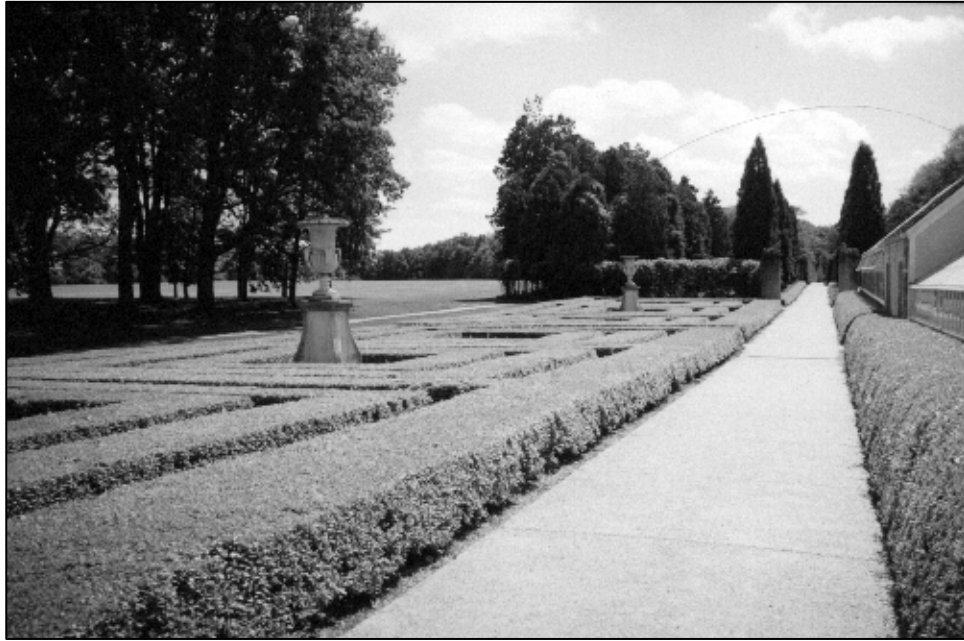
**2001** – This current view is similar to the 1938 view on the previous page except that parterres have widened in the intervening years.

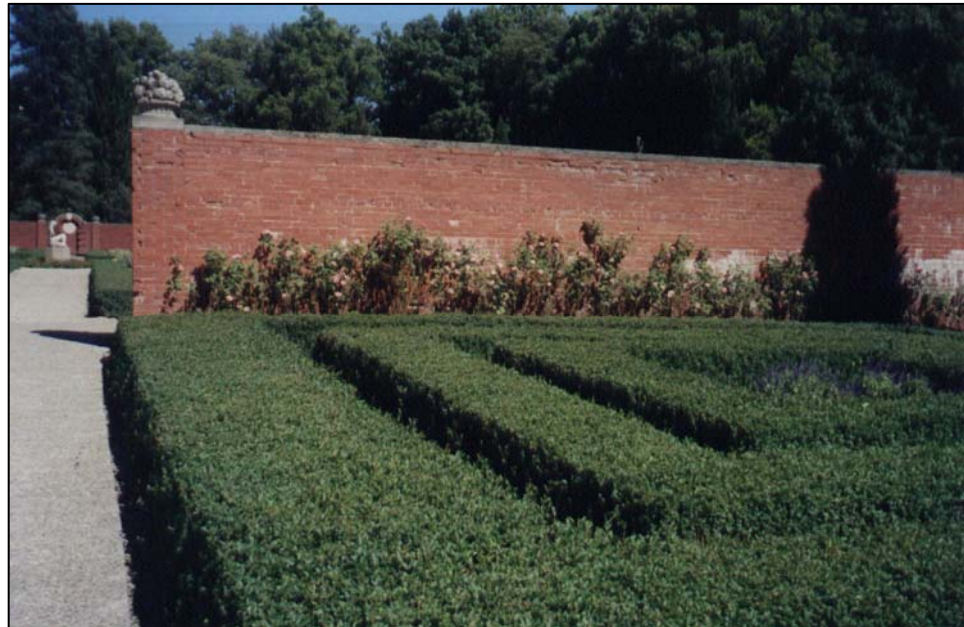
**2001** – This view towards the west wall shows the spalling of the wall and the paucity of plantings. The single arborvitae is a post-1946 addition.

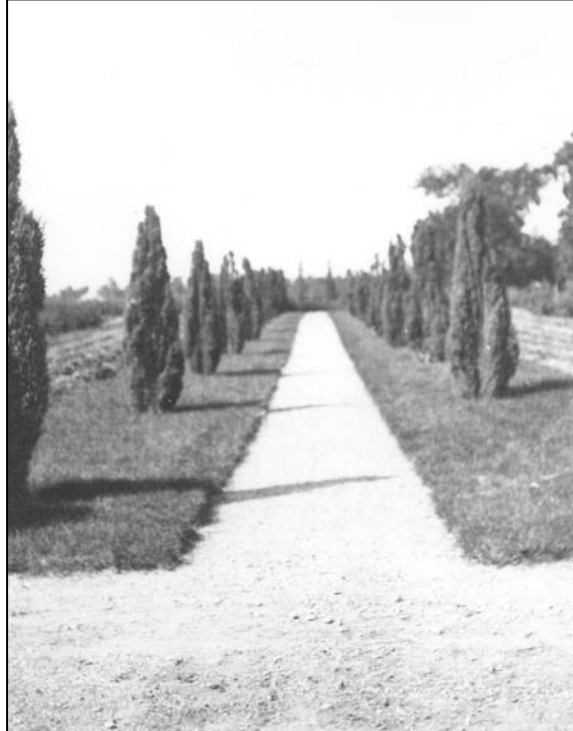
1908 (HGTO-1) Gravel path through center of space, lined with evenly spaced Irish juniper. Rows of very low herbaceous plant materials behind. Loose low hedge at outer edges of garden. Sweet corn was grown in the beds behind.

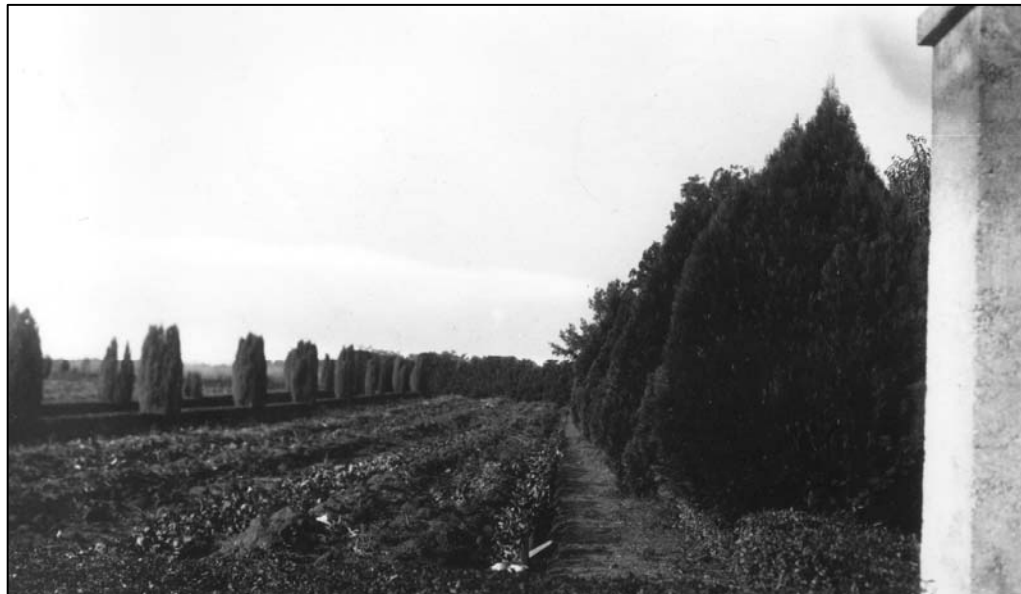
1910 (HGTO-2) View from northeast corner showing low hedge between Irish juniper at far left, rows of herbaceous plantings behind juniper, and single row of arborvitae at right. Sweet corn plants are gone.

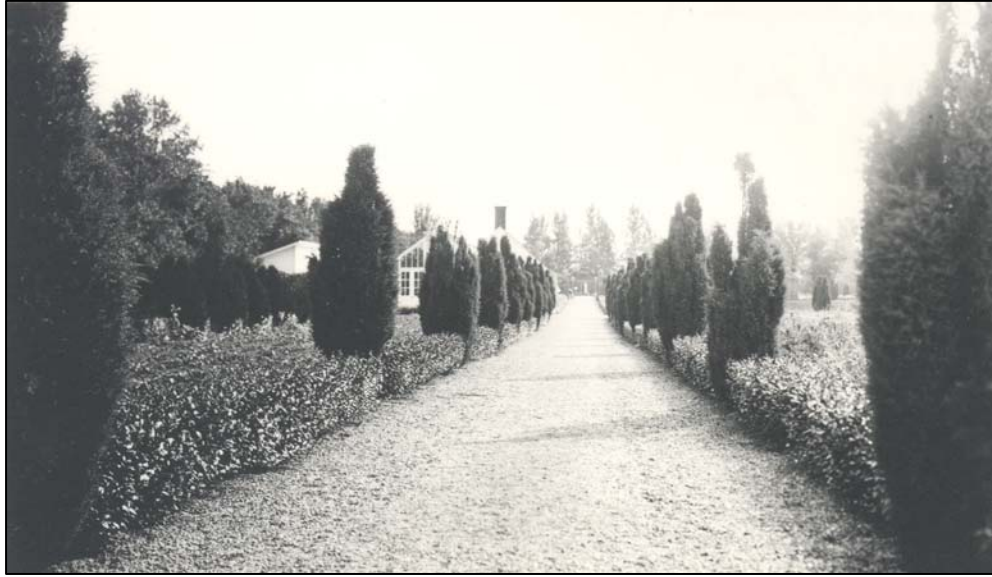
1914 (HGTO-3) View looking east along center path with low, loose hedges (which appear to be unsheared privet) between the Irish junipers.

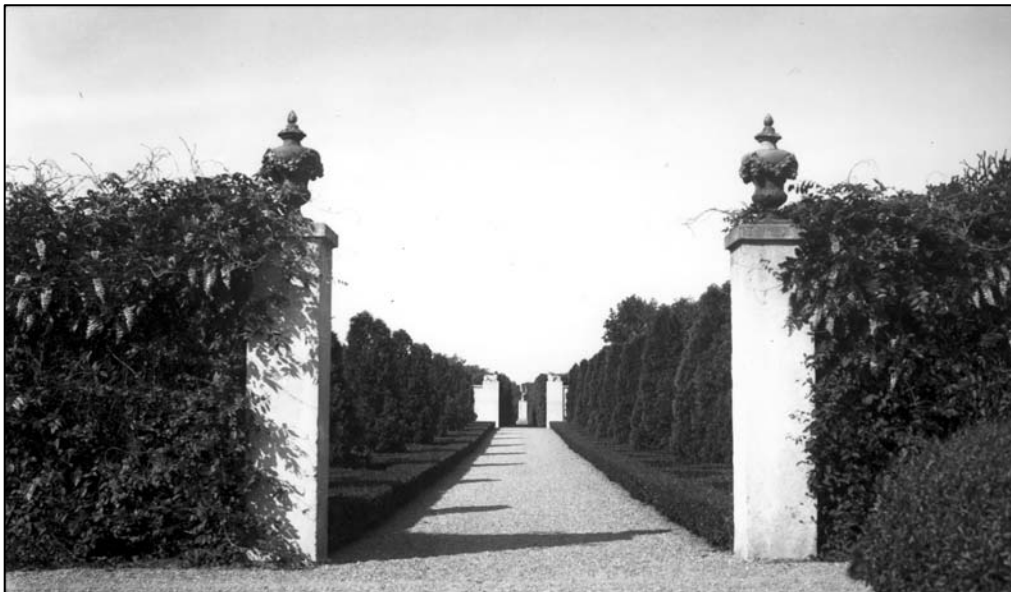
1930 (HGTO-6) The columns at the east end of the garden (foreground) were added by 1918 (see HGHS-10). The adjacent trellises and wisteria were added by 1920. *Assyrian Lions* were added on the pillars at the west end of the garden in 1922. Sometime between 1925 and 1930 the triangular beds were laid out, with gravel used inside the hedges to create patterns. This 1930 view shows ornate garlanded lead urns on top of the east columns and wisteria growing profusely on the trellises. *Arborvitae* have replaced the Irish juniper by this time.

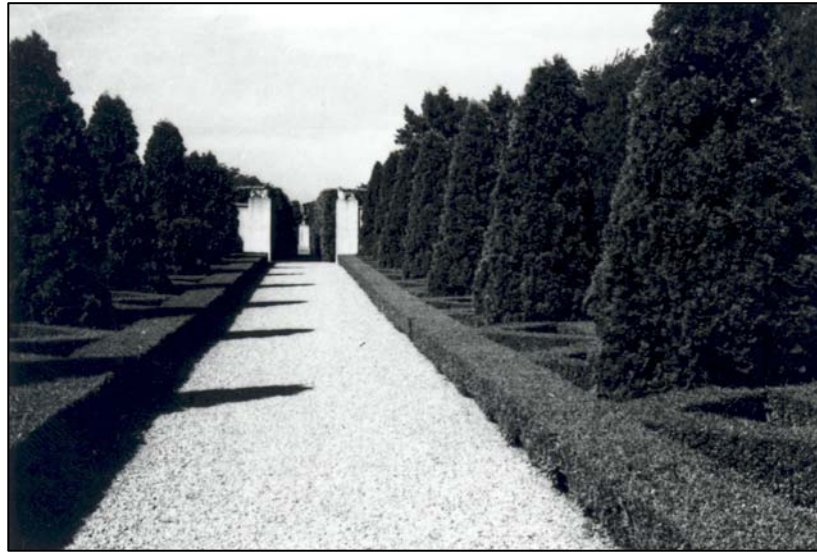
**1935 (HGTO-9)** This 1935 view shows the central portion of the garden much as it exists today. Although not visible in this photo, replicas of the *Assyrian Lions* were placed on top of the east columns in 1935. The lions at the west end of the garden were replaced with replicas in 1976. The arborvitae lining the path have been replaced several times when they were overgrown and damaged by an ice storm.

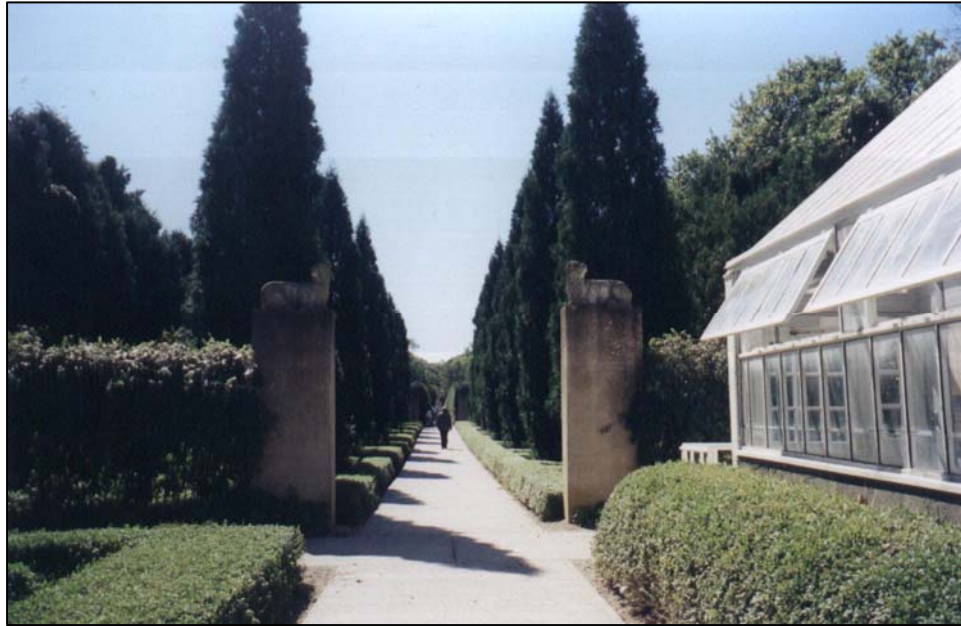
**2001** – The arborvitae lining the main path have grown out of scale with the intended look of the garden. Compare with earlier photos.

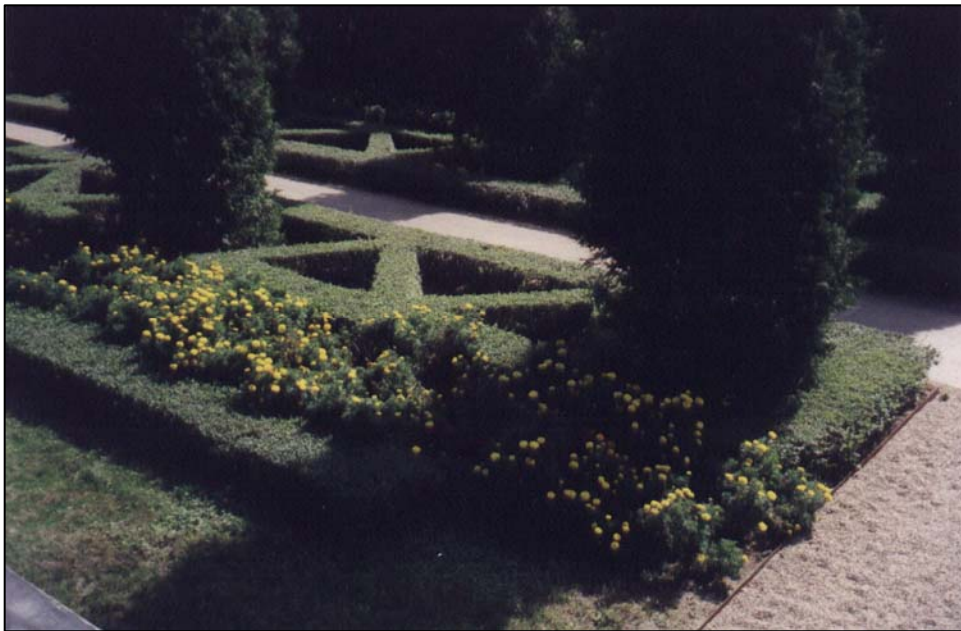
**2001** – Annuals such as the marigolds shown here do not appear in earlier photographs.

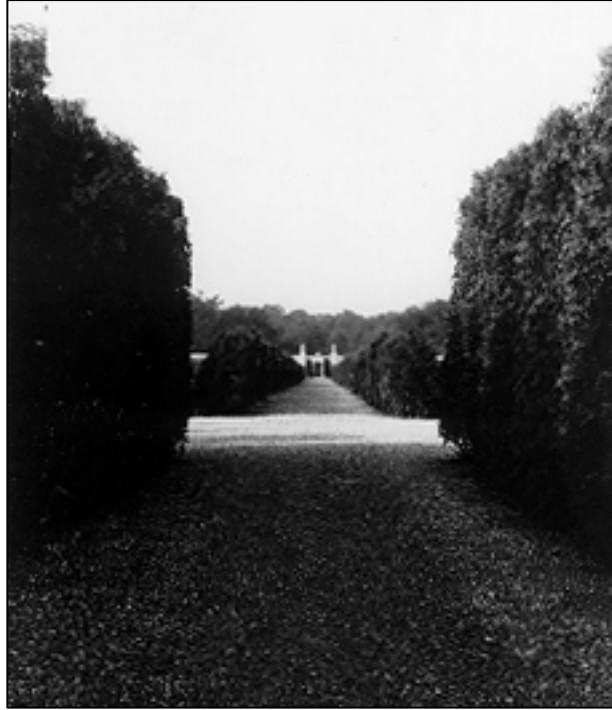
**1917 (HGFO – 4)** View along main pathway of Flower Gardens, looking west towards Chinese Maze Garden.

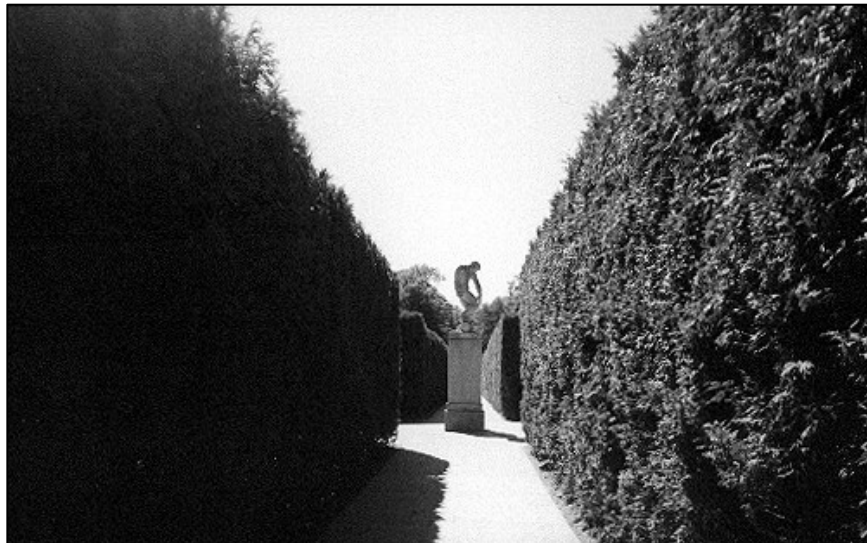
**2001** – View of same path today with replica Adam at the cross axes.

Muriel Scheinman, who compiled a catalog of art at the University of Illinois, described the current Adam, a second-generation copy, “It looks crude and unfinished and lacks artistic fidelity.” A more precise replica of the original Adam should eventually replace the current version.

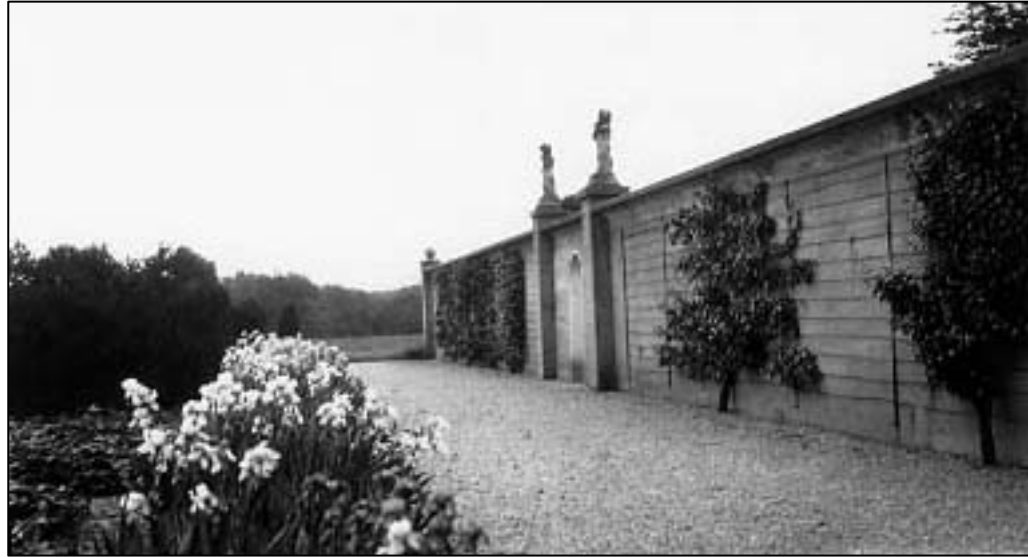
**1925 (HGA-25)** This detail slide illustrates the level of refinement and careful maintenance that existed under Robert Allerton's stewardship. While the structure of the flower gardens remains intact, loss of detail, overgrown plant materials and lack of species diversity in the ornamental plantings have changed the overall effect.

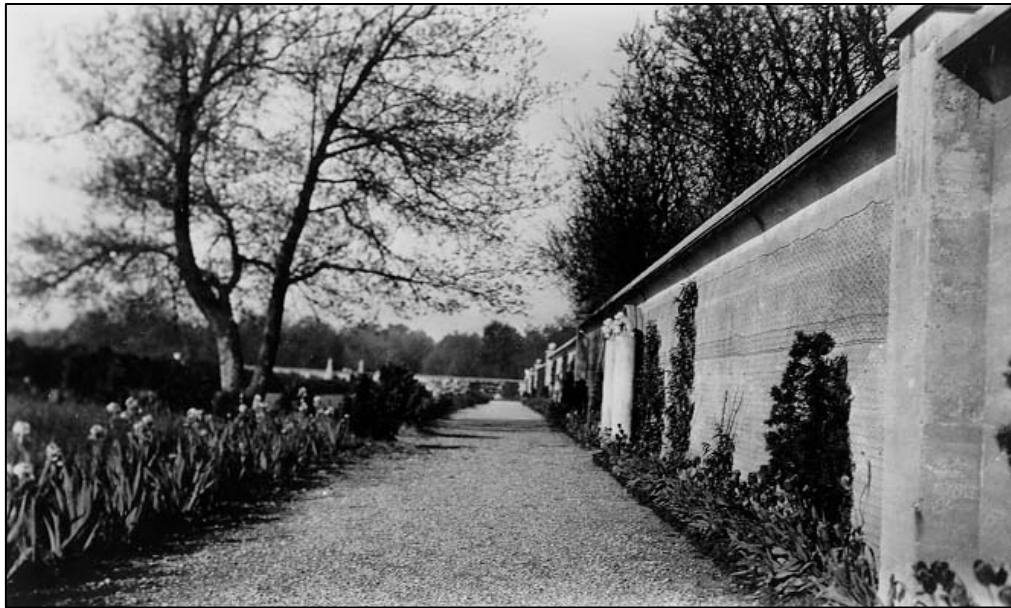
1918 (HGHF-6) View west along northern edge of garden with tree and irises. Note screening on wall to support vines, which were intended to cover the wall.

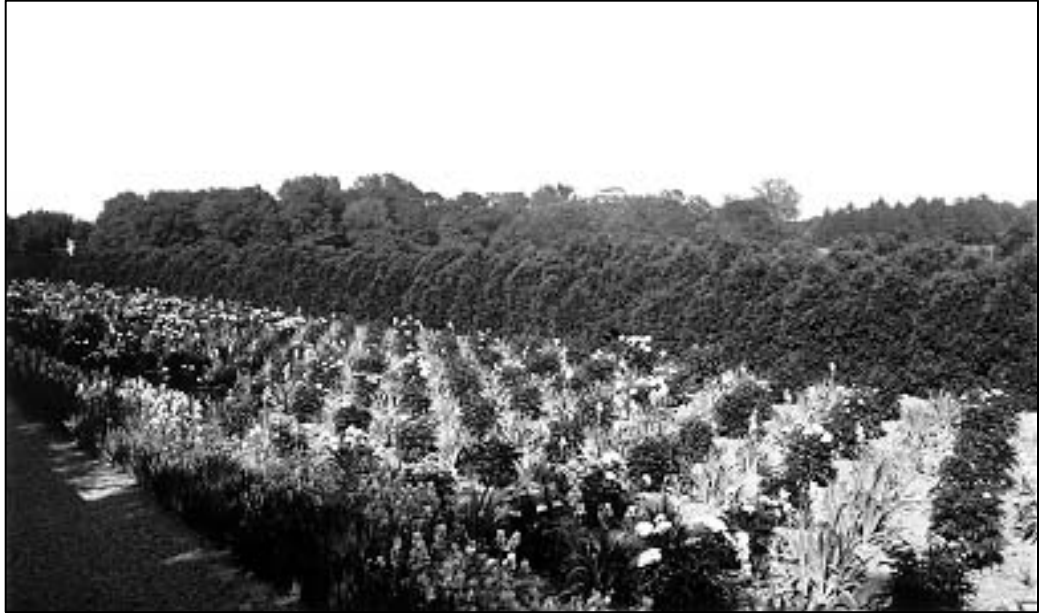
1925 (HGHF-15) View from catwalk showing peonies interplanted with irises, which were later replanted to the border as the blooming sequence was too close to that of the

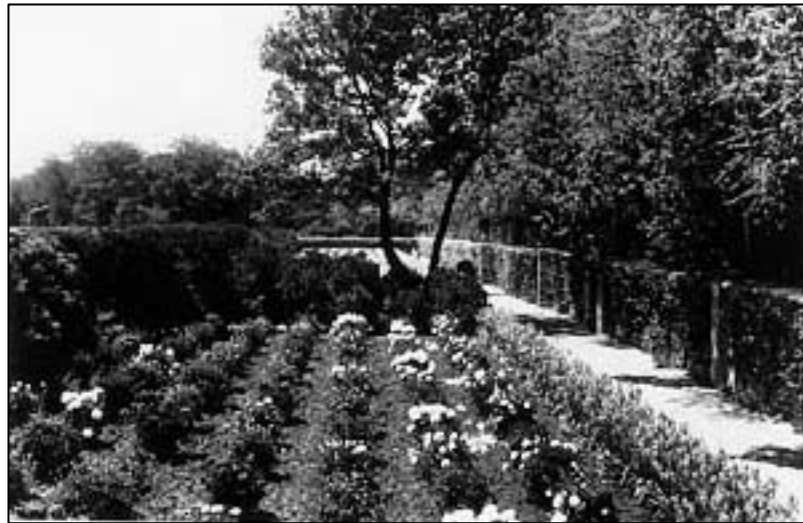
1935 (HGHF-32) View west showing peonies in bloom. Nothing appears to be interplanted at this time although there is a border of irises along the northern edge of the peony bed.

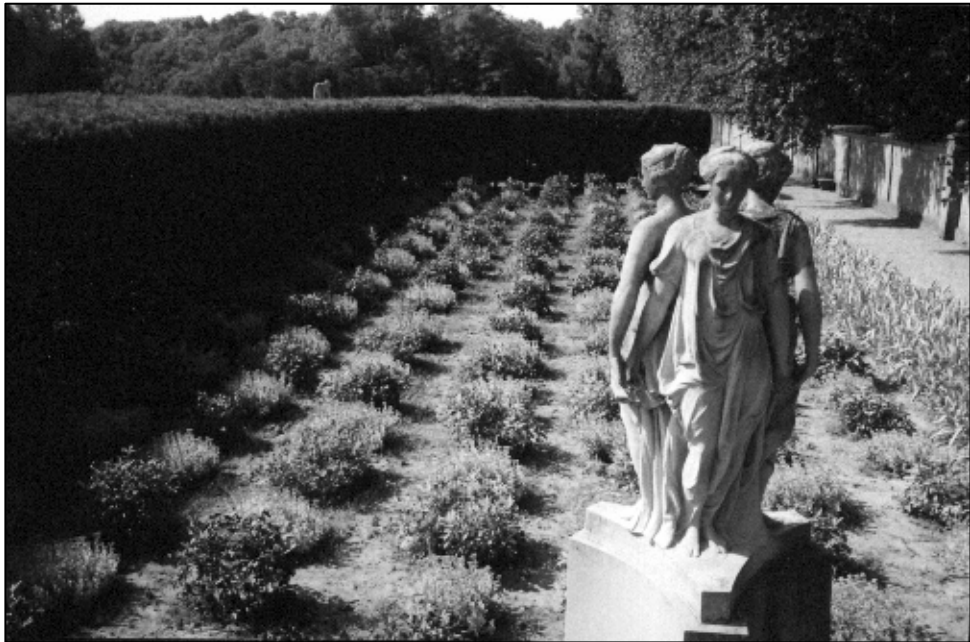
2001 – View of peony garden from roof of stair tower in Triangle Parterre Garden.  
The *Three Graces* were not placed here until 1970.

This sculpture was placed here in the 1970s. It is inappropriate in the Peony Garden and should be relocated to its original site or placed in storage until an appropriate location can be found.

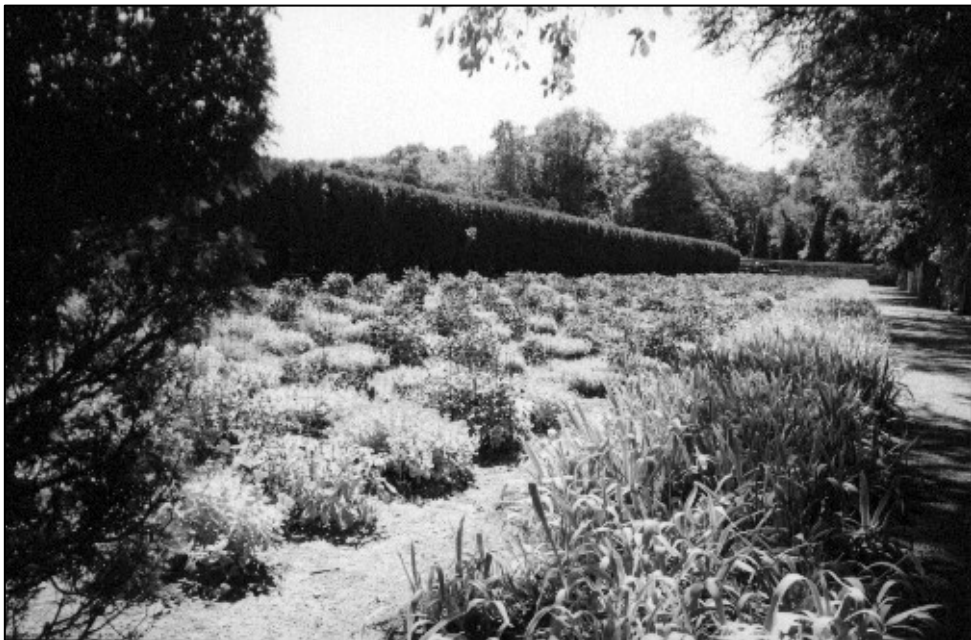
2001 – View of Peony Garden looking west with irises in the foreground.

This garden retains its basic form and structure but plantings have become less diverse over time, with plantings along the wall almost entirely missing. The current appearance of the garden is far less intricate and seasonally interesting than it was in Allerton's time. The recommended approach is to restore plantings to their circa 1946 appearance.

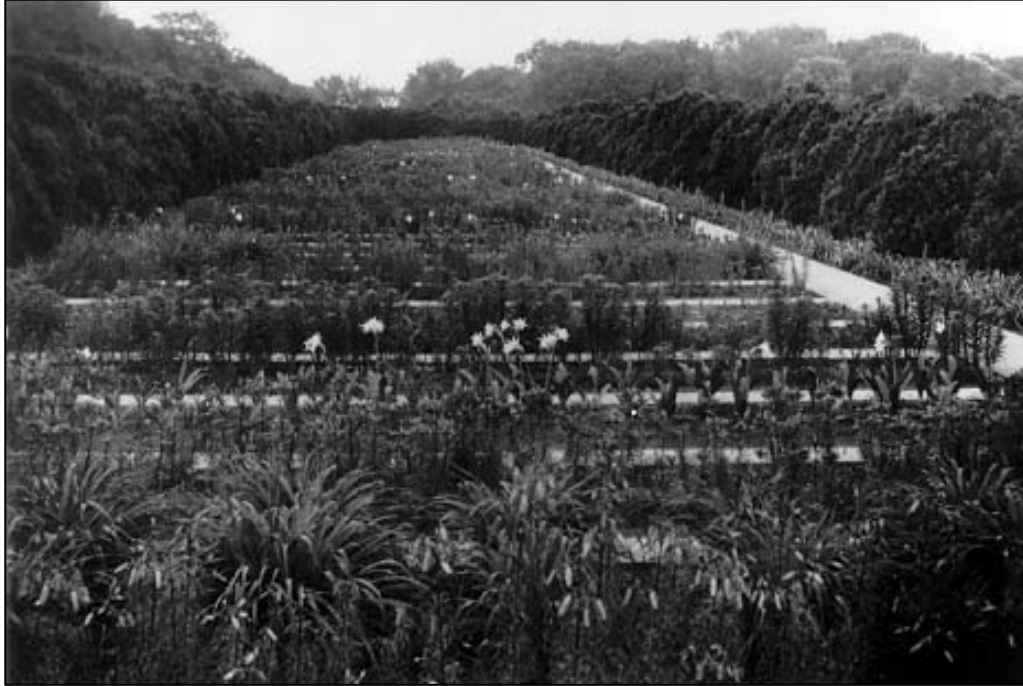
1935 (HGFB-3) View of the bulb garden in its prime, with 105 alternating rows of summer bulbs. Spring bulbs were primarily daffodils, narcissus and jonquils.

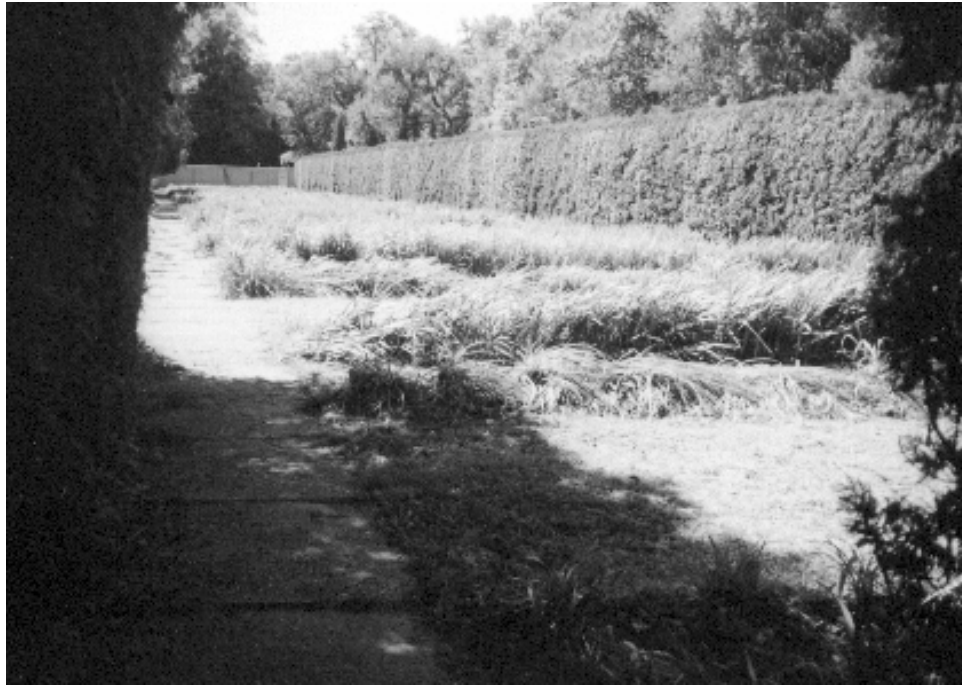
**2001** – Today the Bulb Garden is much simpler than it was during Allerton's time, with less intricate plantings and path system.

This garden is attractive during its peak season but of less interest to visitors during the rest of the year. Restore multi-season bulb and annual plantings, based on 1948 plant list and improve garden maintenance. Replace arborvitae hedge along south side of the garden as indicated in 6D.

Replace missing north/south garden walkways.

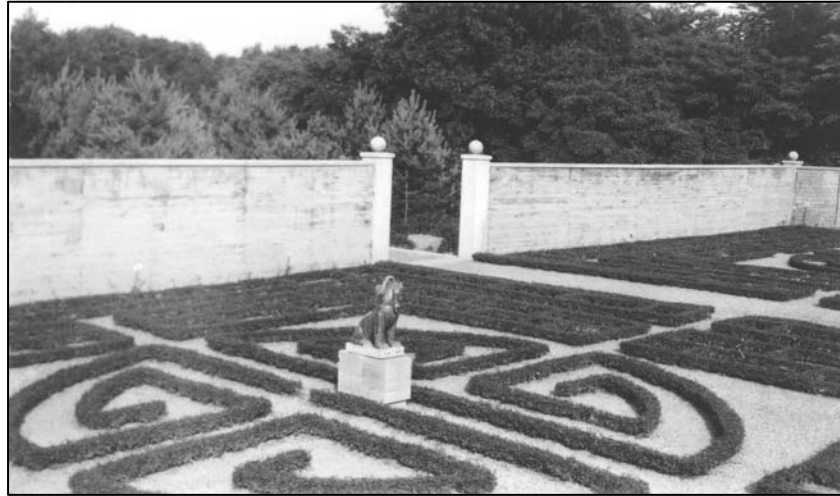
**1912 (HGC-1)** This very early view looking northwest shows the basic features of the garden: high concrete walls, privet hedges in an elaborate maze-like pattern, and *Fu Dogs* at the center of each of the two maze squares. Hedges are very low and narrow with groomed pea stone in between.

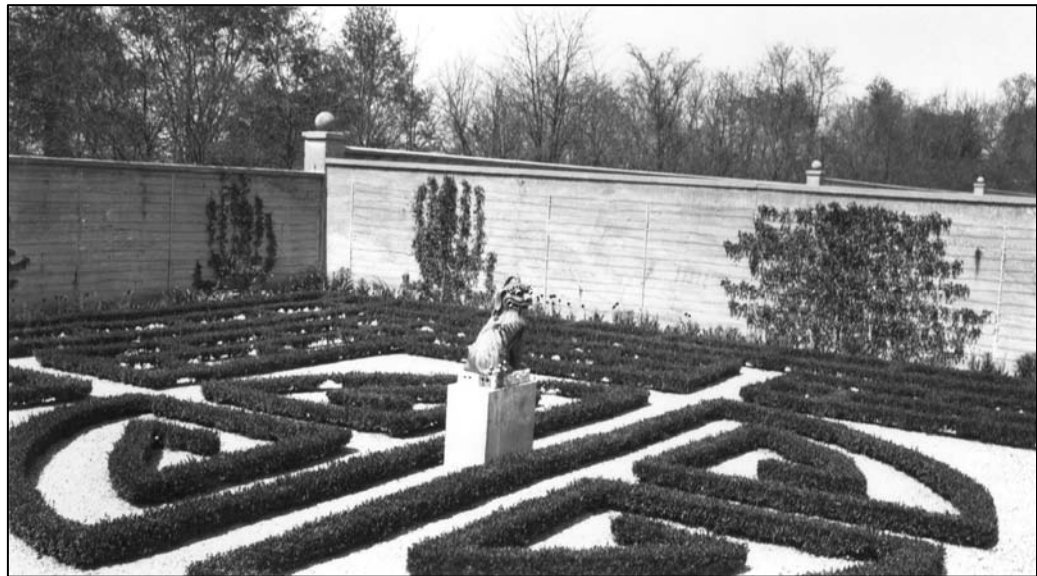
**1915 (HGC-3)** By 1915 espaliered apples and pears had been added on the walls and herbaceous plantings around the perimeter. This view is looking northeast with the Peony Garden wall in the background.

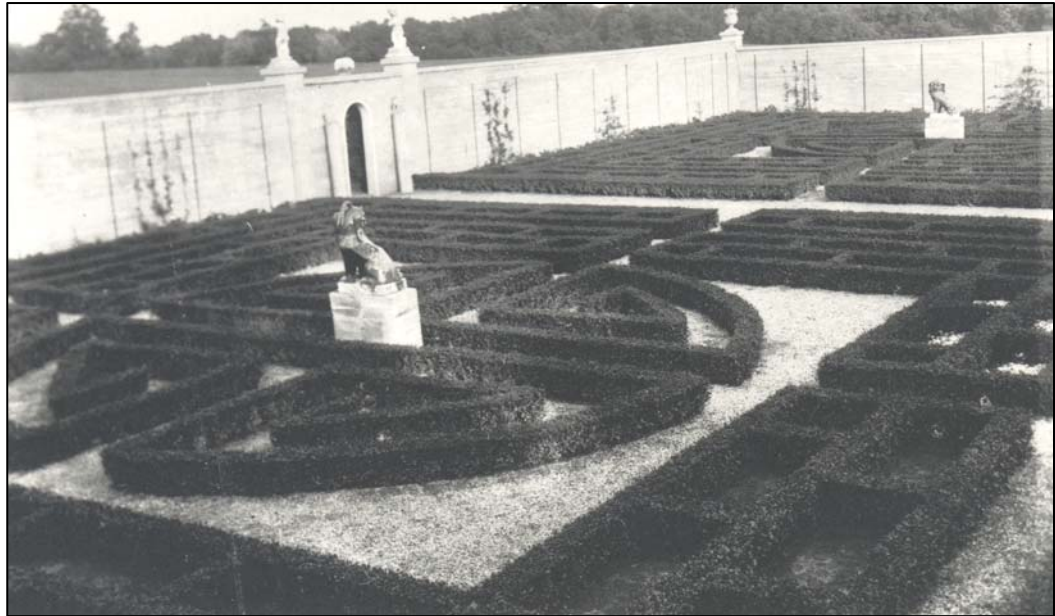
**1920 (HGC-9)** This view looking southeast shows the addition of statuary on top of the east wall and tall cylindrical pedestals on either side of the east entrance. Note urn on top of wall at corner of garden.

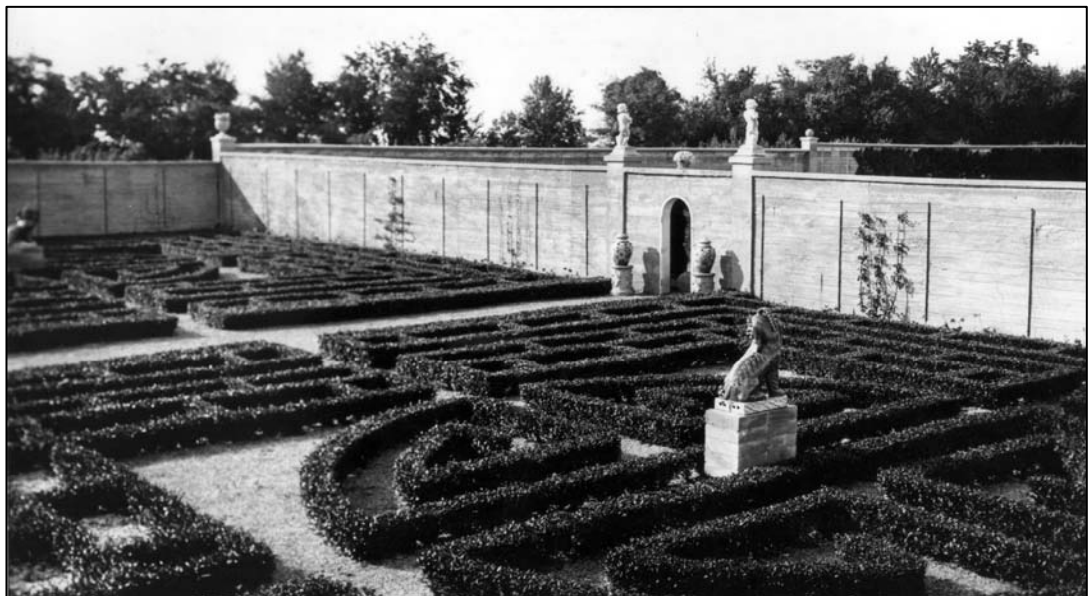
**1925 (HGC-12)** By 1925 the statues on either side of the east door had been changed to urns or vases. Later that year the Chinese *Fu Dogs* shown here were replaced by *Chinese Goldfish*, which are still in the garden.

Conservator's report indicates that the marble *Chinese Goldfish* are deteriorating rapidly and recommends that they be replaced with newly carved copies, with originals preserved indoors. (See 1994 Forsythe survey and CSOS 2000 condition report for specific treatment recommendations.)

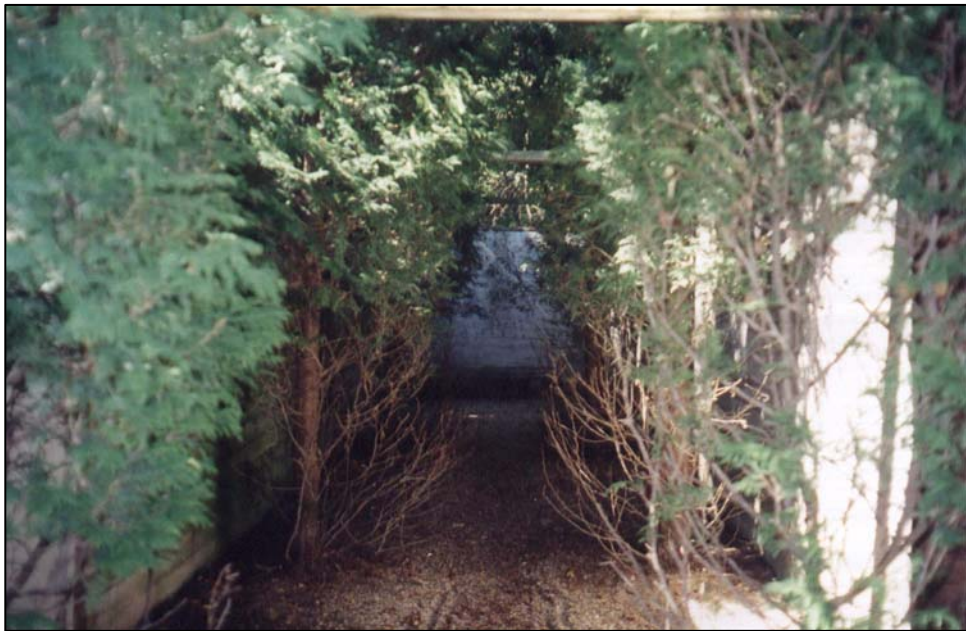
**2001** – This narrow passageway east of the Chinese Maze Garden originally led to two stair pavilions. Remnants of one of these towers remains. The arborvitae that Allerton planted here have grown too large for the space and obscure the new ADA access path.

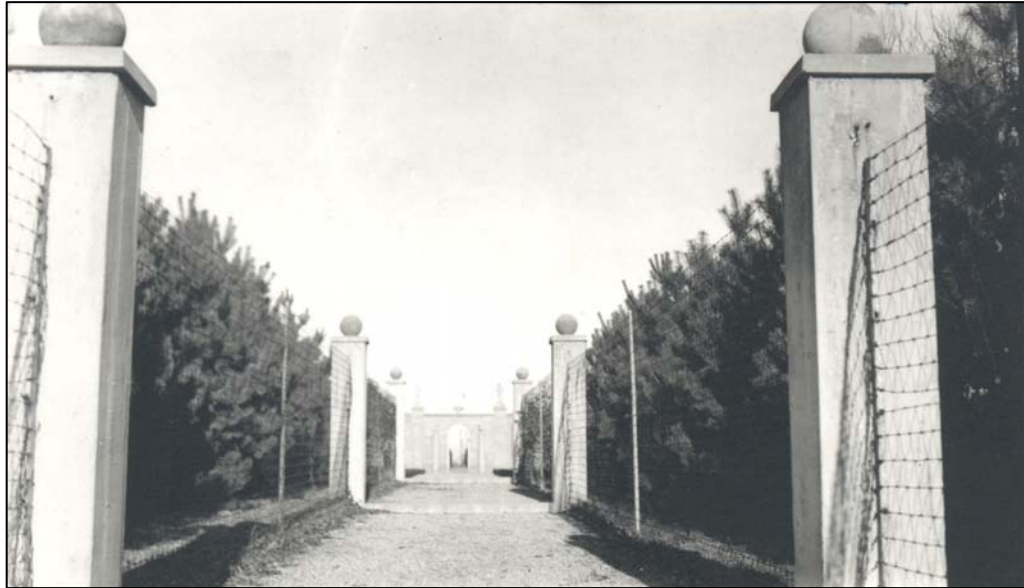
**1912 (HGET-1)** View east during construction circa 1912, with Chinese Maze Garden at rear. This garden was intended as an evergreen-lined passageway, punctuated by six pairs of columns surmounted by orbs. Wire trellises between the columns defined the edges of the space. This garden is lower in elevation than the Chinese Maze Garden, note steps at

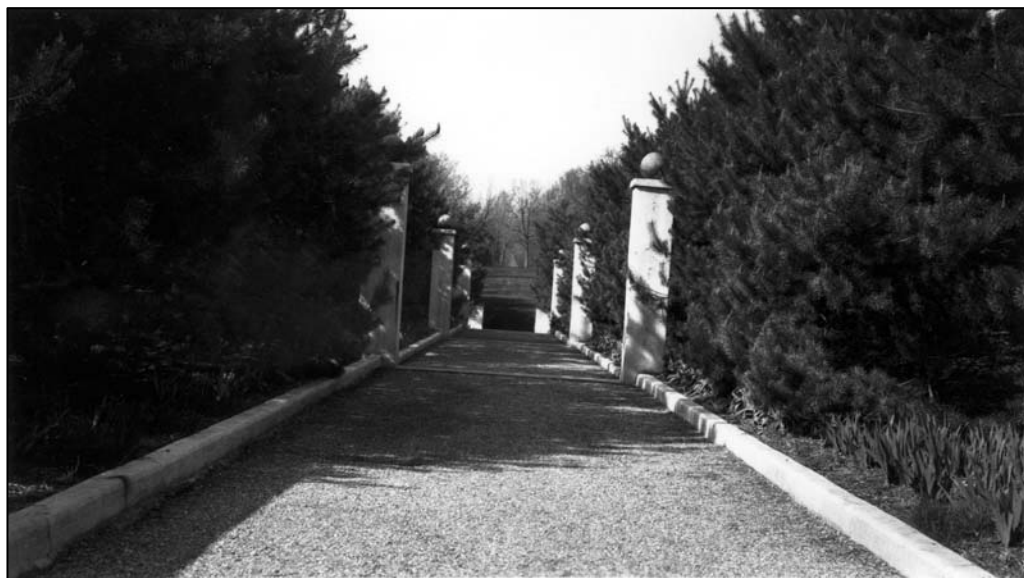
**1912 (HGET-2)** This view looking west shows the garden soon after completion. A low curb has been added and there are some herbaceous plantings at the lower right. At times the evergreens were sheared to make the columns appear more dominant.

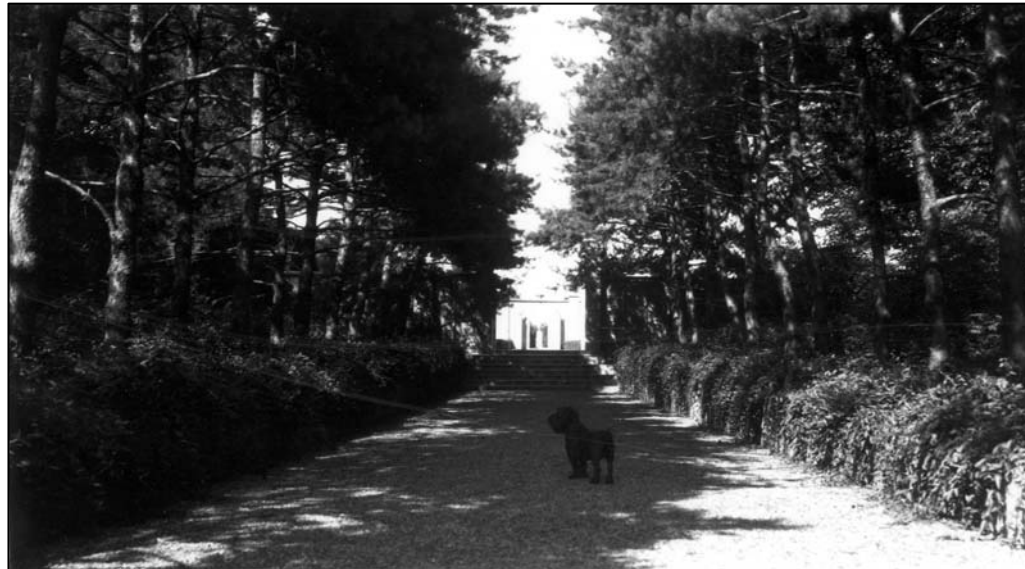
**1925 (HGET-6)** This view east towards Chinese Maze Garden shows the garden as the trees matured. By this time the garden was more enclosed and the pillars and wire trellises had been removed. The low curb is covered with ground cover.

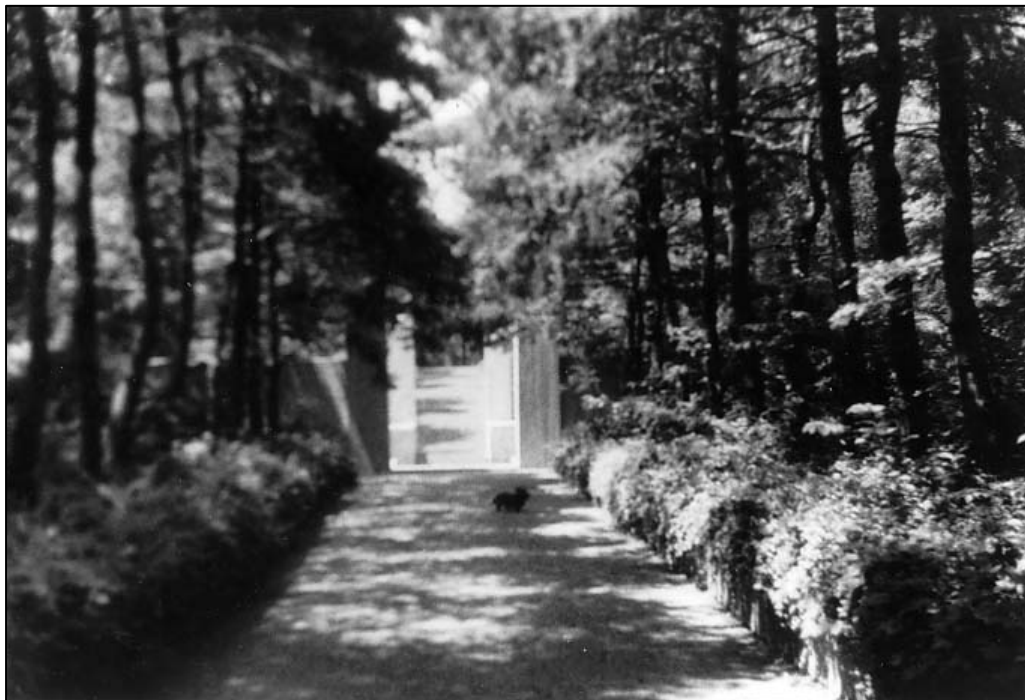
**1935 (HGET-12)** This view looking west towards the Sunken Garden is similar to the one above. The *Chinese Musicians* were not moved here until after a fire destroyed the Lost Garden pavilion in 1972.

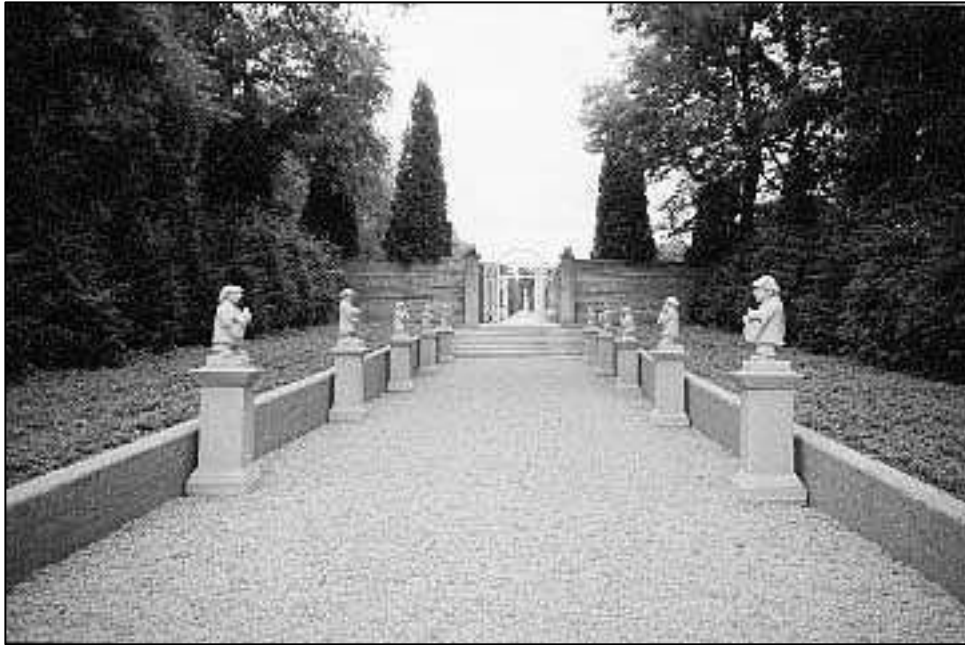
**2001** View looking east towards Chinese Maze Garden with newly planted hemlocks and vinca on either side of the path and newly cleaned and recarved musicians and bases.

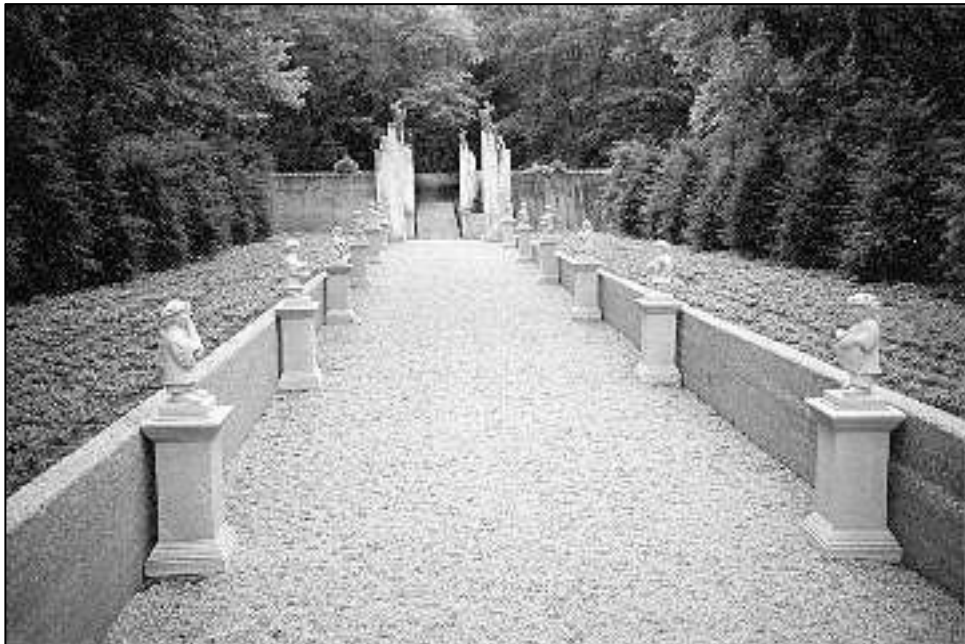
**2001** – View looking west towards Sunken Garden.

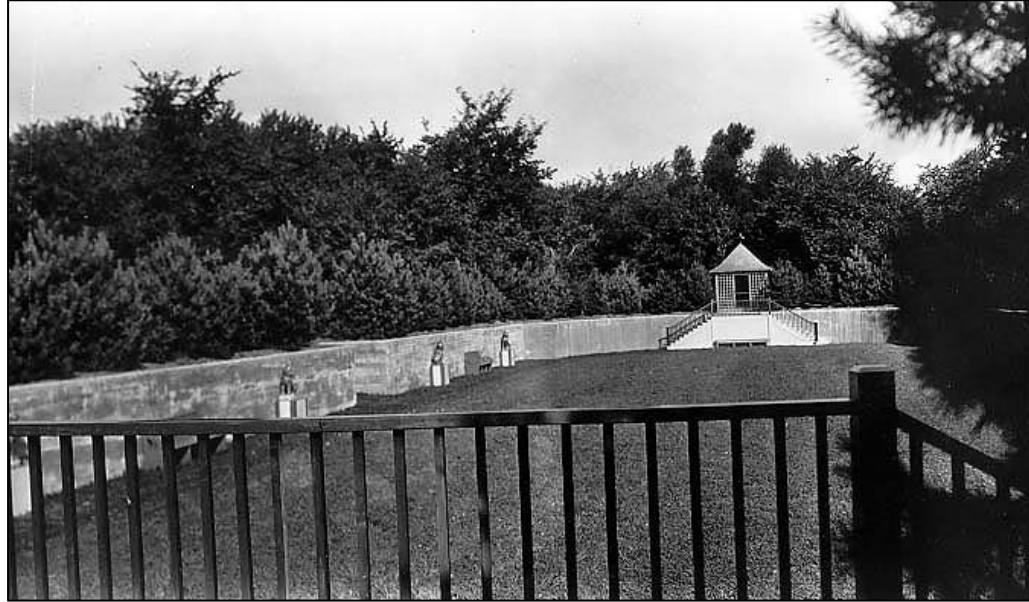
**1917 (HGS-4)** This view shows the garden soon after construction with only the lower wall in place. *Fu Dogs* were placed around the interior of the garden floor. The site was previously used as a landfill and composting operation (which was relocated elsewhere).

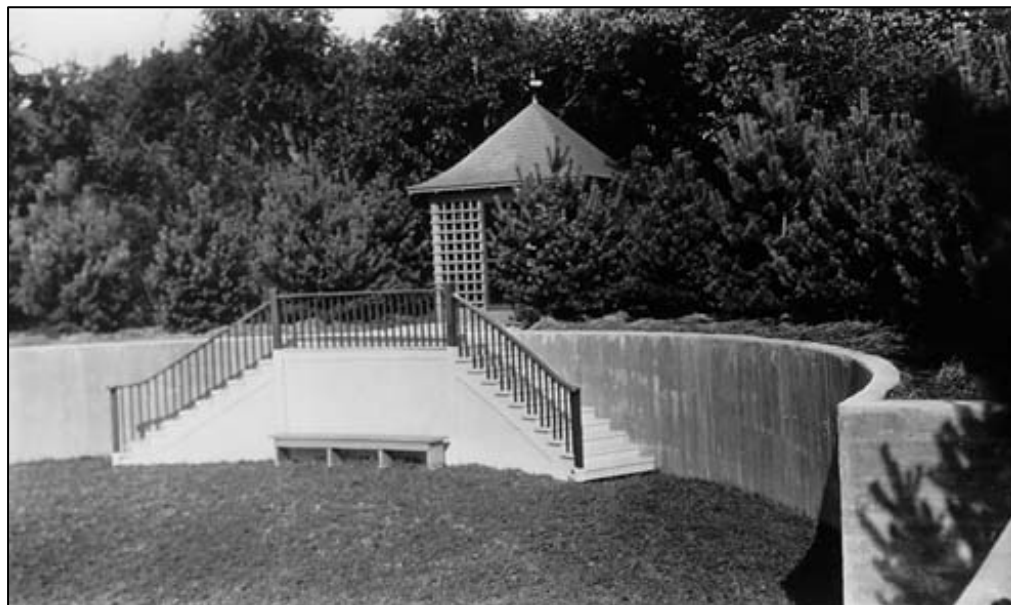
**(HGS-3)** Early detail of concrete stair and wooden gazebo. A two-story wood and concrete gazebo replaced this in the 1920s.

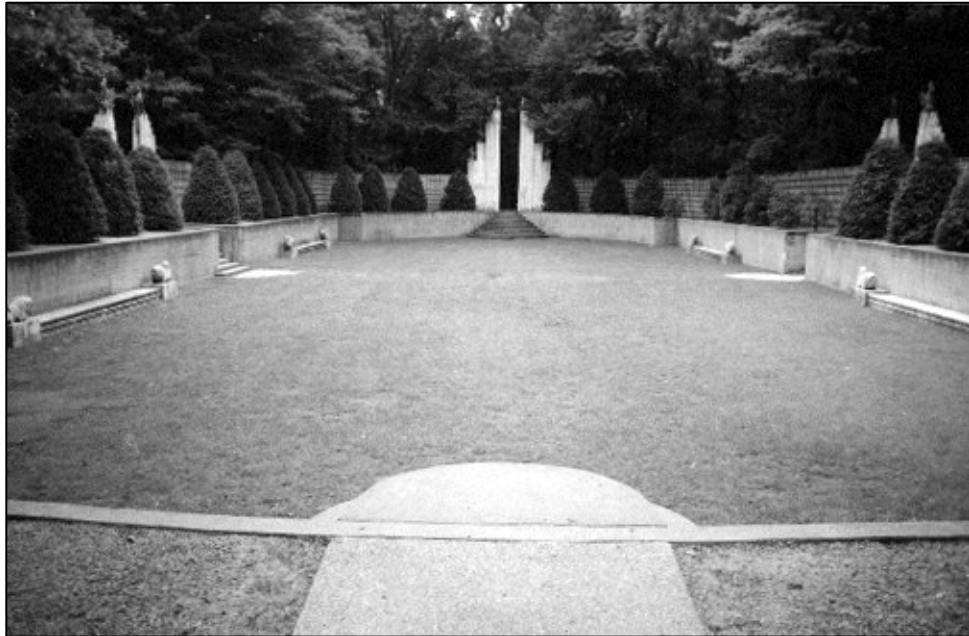
**2001** – Current view of Sunken Garden showing faded walls and evergreens that appear too large and dense for this space.
