# **CULTURAL LANDSCAPE TREATMENT PLAN**

**ROBERT ALLERTON PARK**

**Cultural Landscape Treatment Plan**  
Robert Allerton Park  
Monticello, Illinois

September 2001

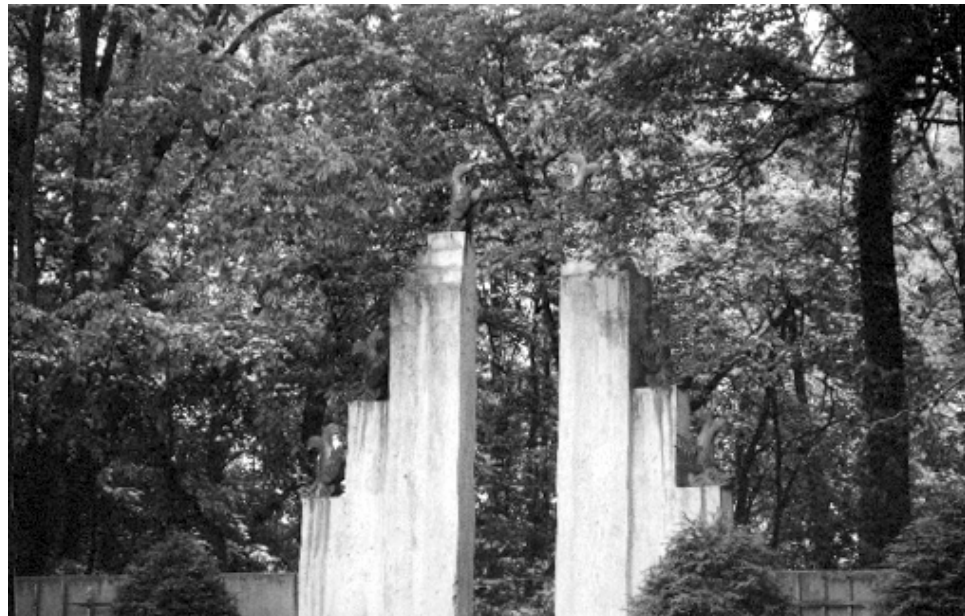
**2001** – Overhanging trees are a particular threat to the Japanese *Guardian Fish*.

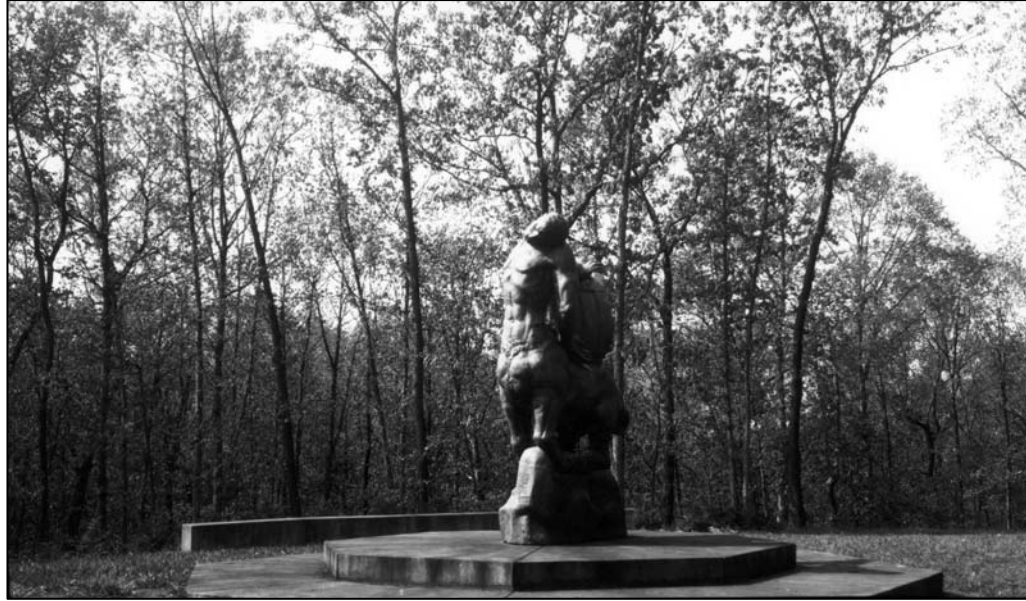
1935 (HGCN-8) Early view of *Centaur* in its setting, with pedestal and benches, but no hemlocks behind the benches.

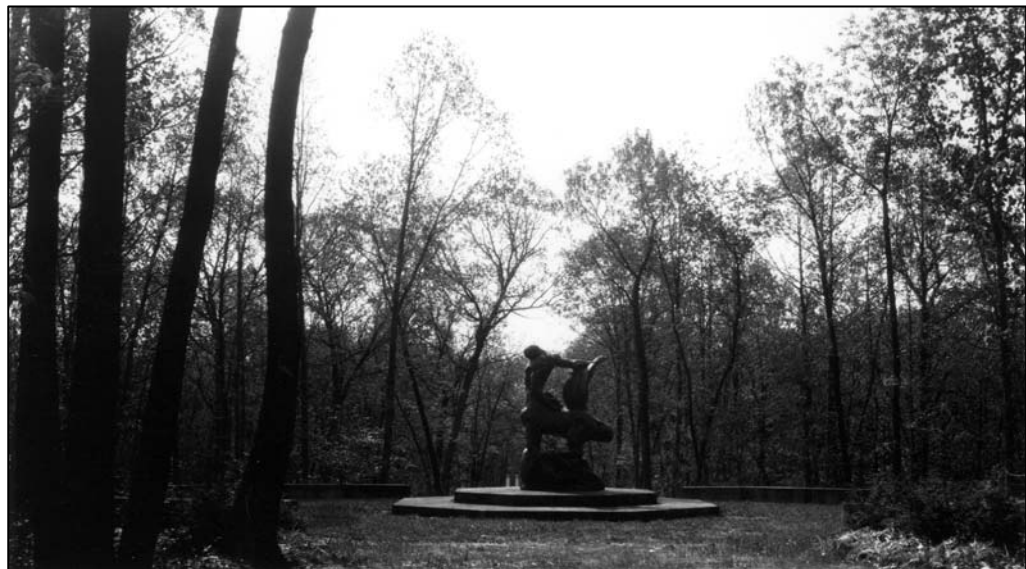
1935 (HGCN-9) Similar view showing the openness of the space at this time.

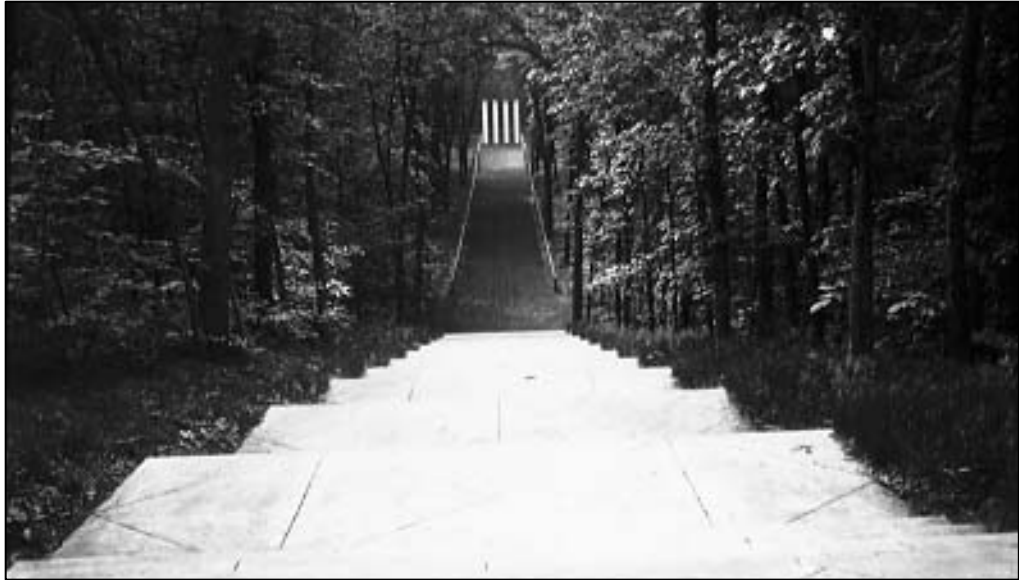
**1935-40 (HGCN-17)** This view looking down the steps towards the south pylons illustrates a much stronger visual connection than exists today.

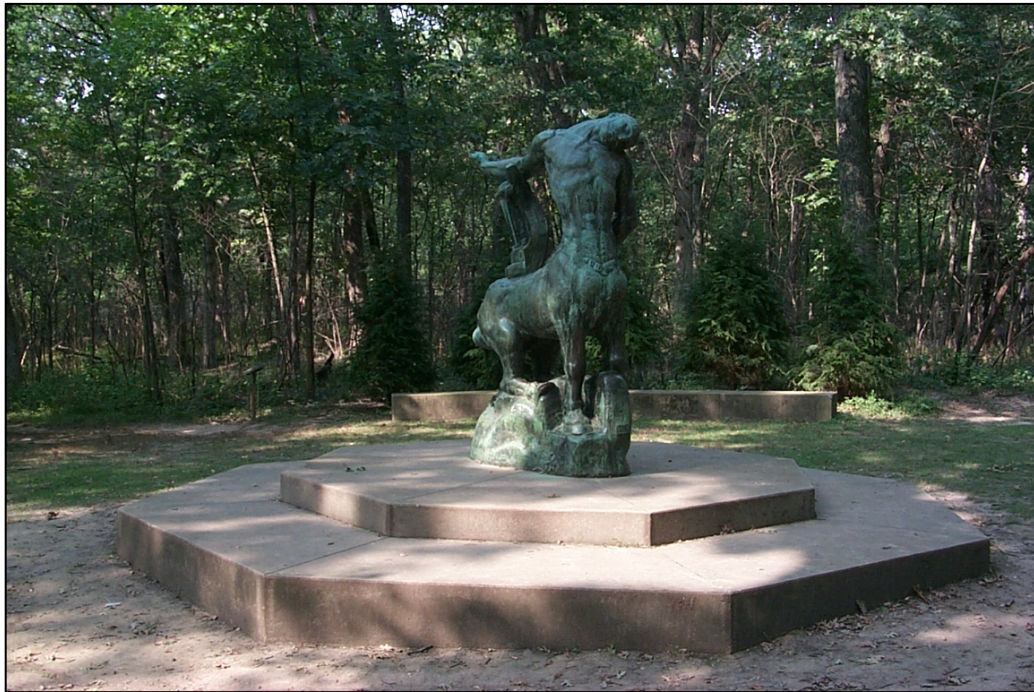
**2001** – The *Centaur*, with its gold flecked bronze finish, was meant to be seen in the sunlight rather than the shade. Compare this view with HGCN-9, taken in 1935.

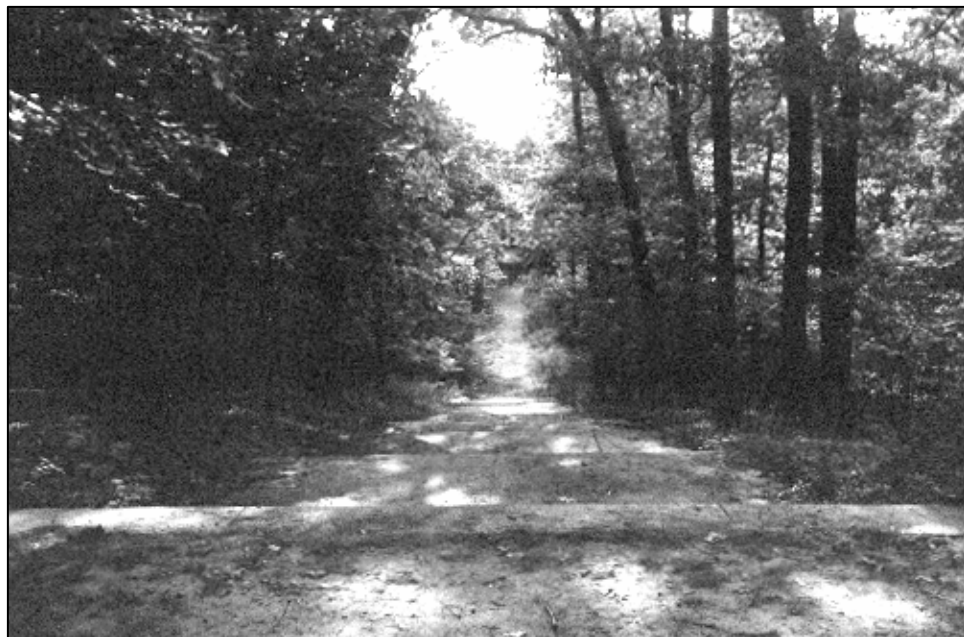
**2001** – The connection of the *Centaur* with its outlying spaces has been largely obscured by the growth of vegetation. This view is similar to HGCN-17 from the late 1930s except that the pylons are no longer visible.

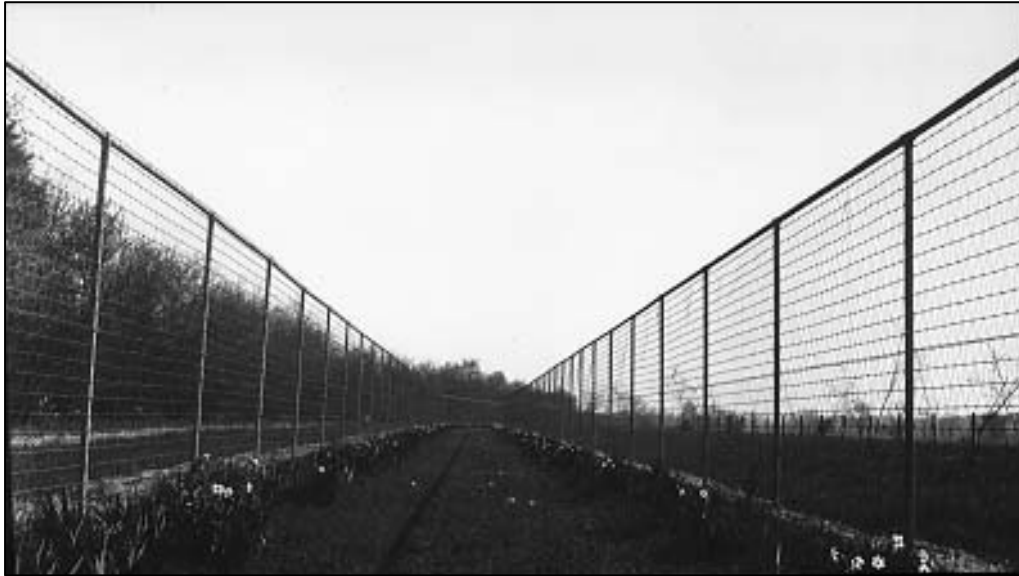
1918 (HGFD-1) Early view of the Vine Walk showing the trellis structure and bulb plantings. Note the openness of the surrounding pasture land.

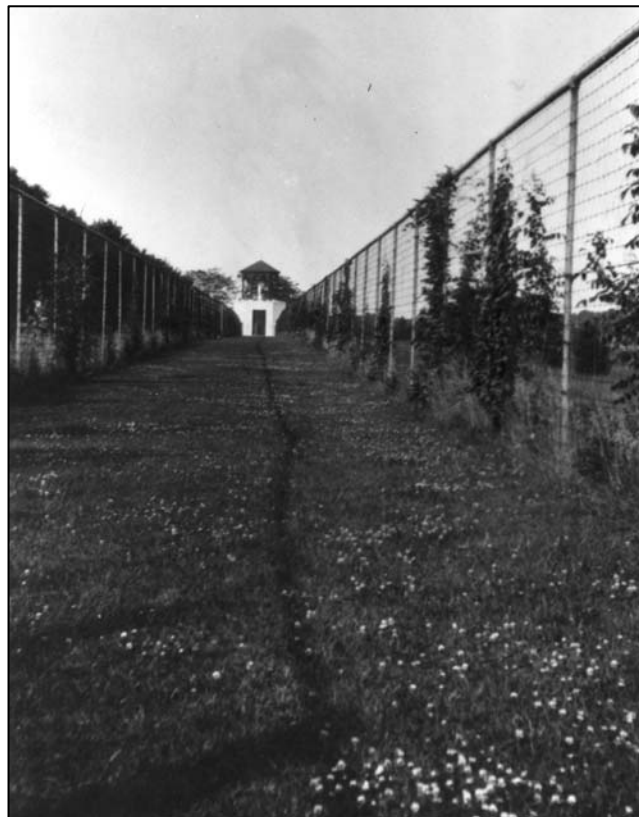
1925 (HGFD-2) Slightly later view with the House of the Golden Buddhas in the

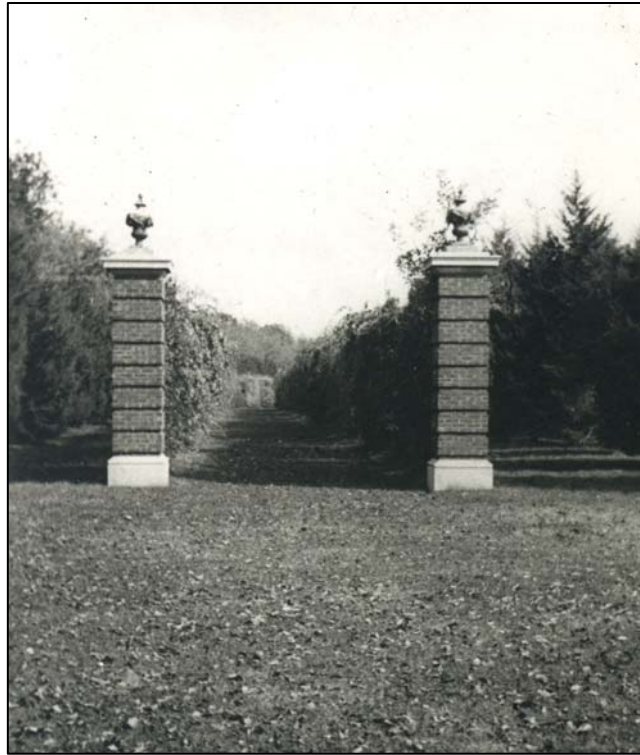
**1938 (HGFD-3)** View east along the Vine Walk from the house entrance drive. The pillars still exist but this section of the Vine Walk has since been removed.

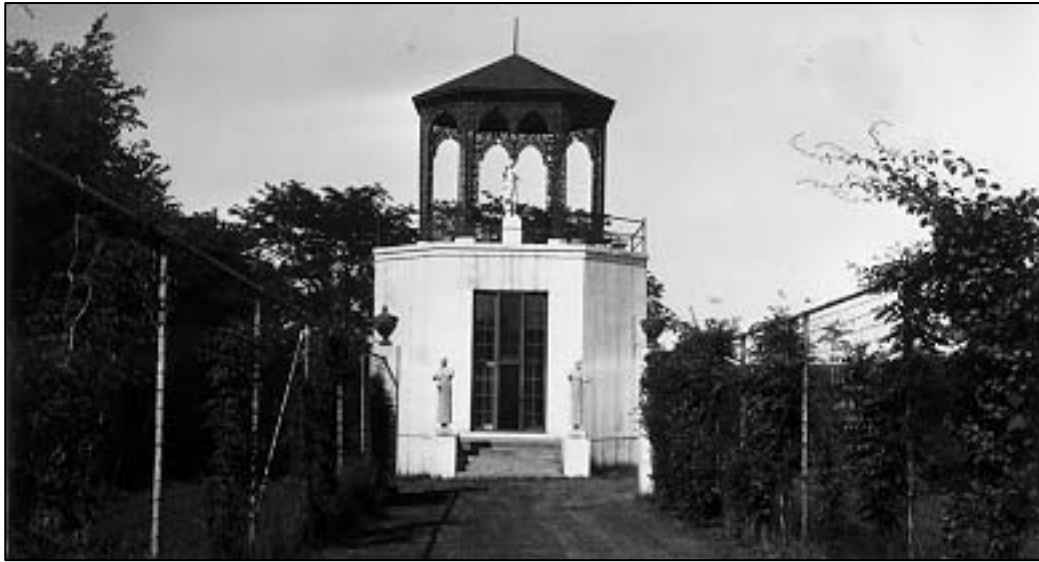
1925 (HGFF-03) Early view of the House of the Golden Buddhas with Vine Walk in foreground.

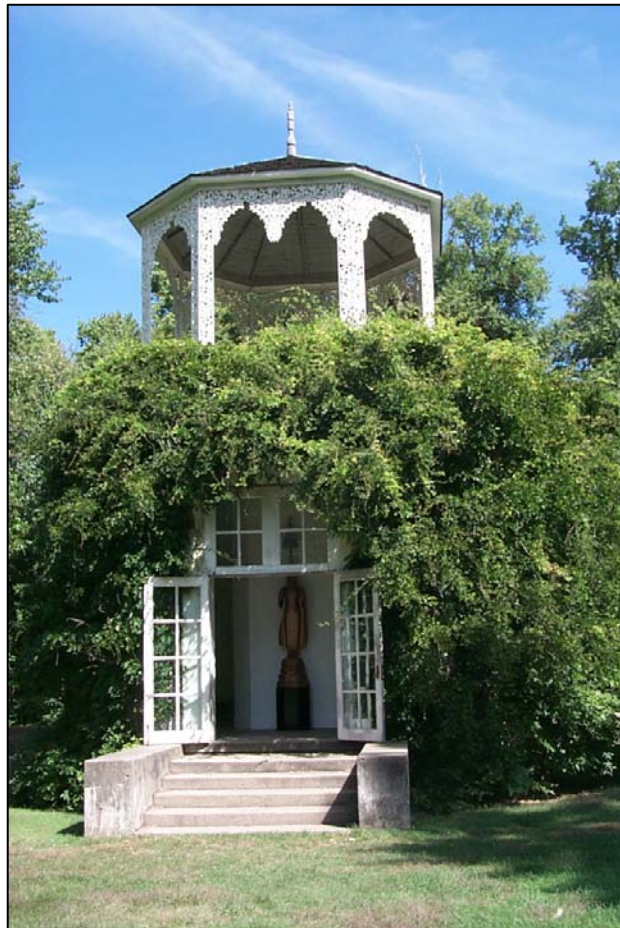
2000 – Current view of House of the Golden Buddhas covered with wisteria. Top is now white and replacement doors (which partially obscure view of sculptures) have been added for security.

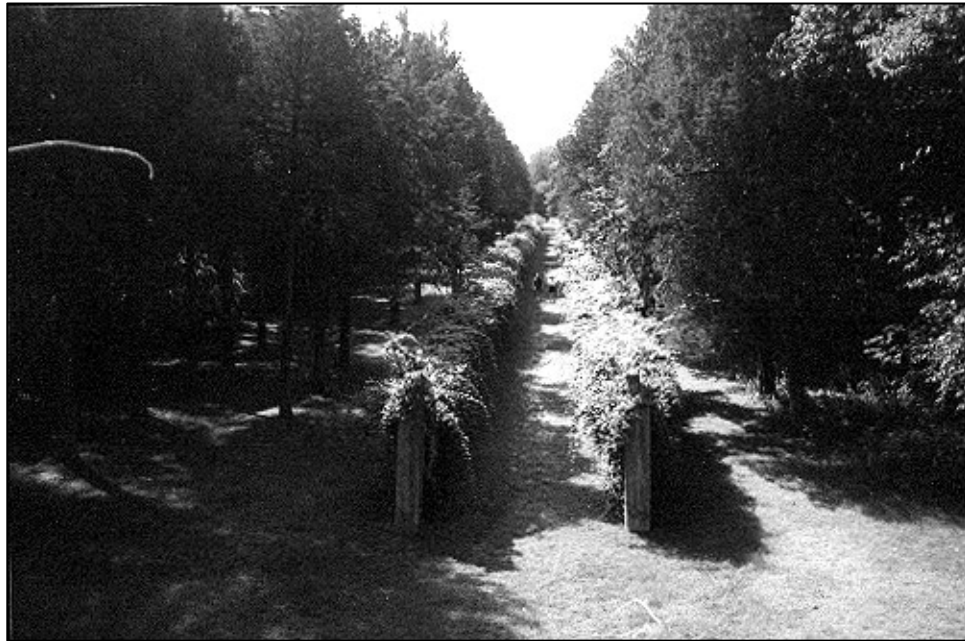
**2001** – The east end of the Vine Walk, seen here from House of the Golden Buddhas, is from the same point as HGFF-1 taken in 1944. This section of the Vine Walk retains its basic form but the intended plantings have largely been replaced by invasive vines.

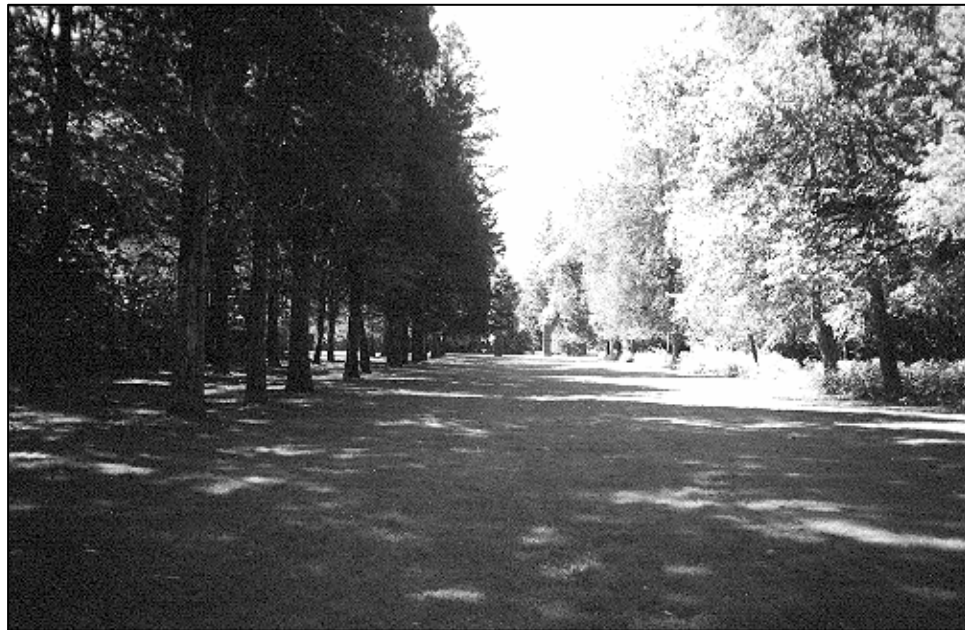
**2001** – The west section the Vine Walk is missing and forest has grown up in the surrounding areas that were initially open fields. Remnant cedars line the narrow clearing where the Vine Walk was located.

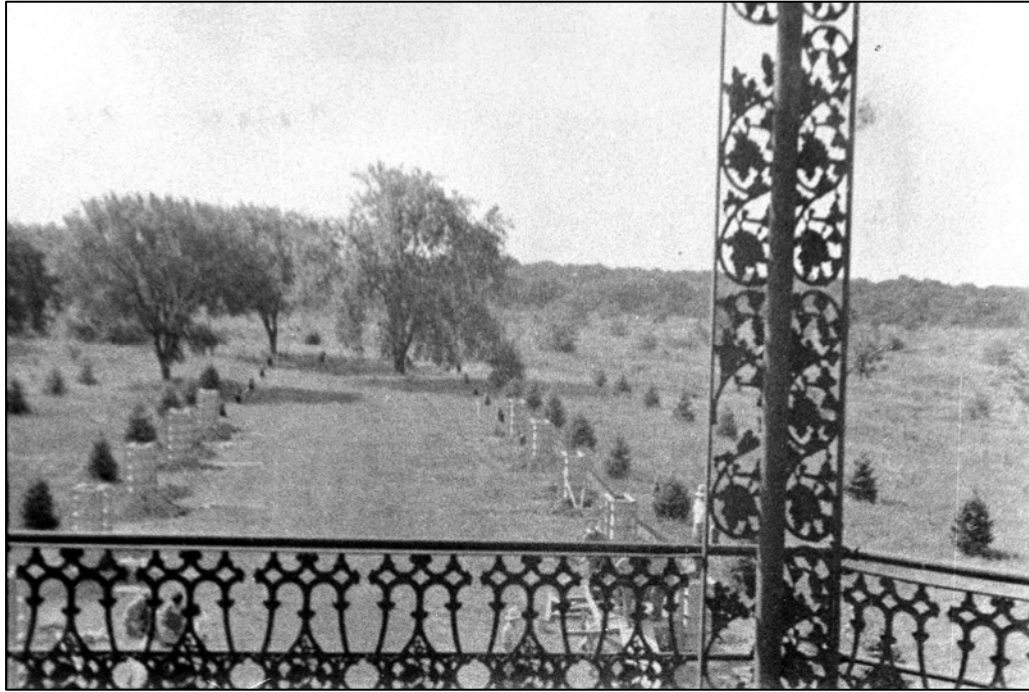
1932 (HGFG-1) This view shows the Fu Dog Garden during construction. Note low triangular hedges in front of pedestals, openness of landscape beyond, and small size of fir trees behind *Fu Dogs*.

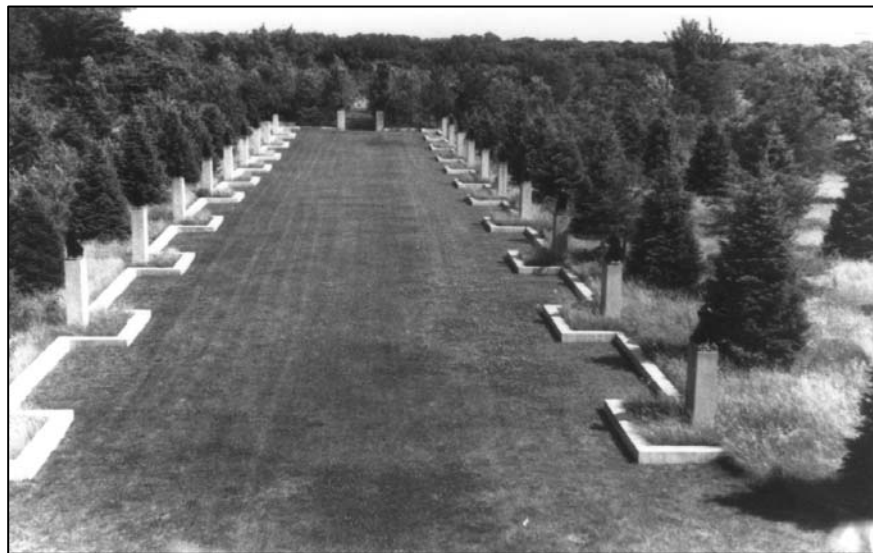
1937 (HGFG-7) This view, also taken from the House of the Golden Buddhas, shows the garden with rectangular curbing in place and maturing trees.

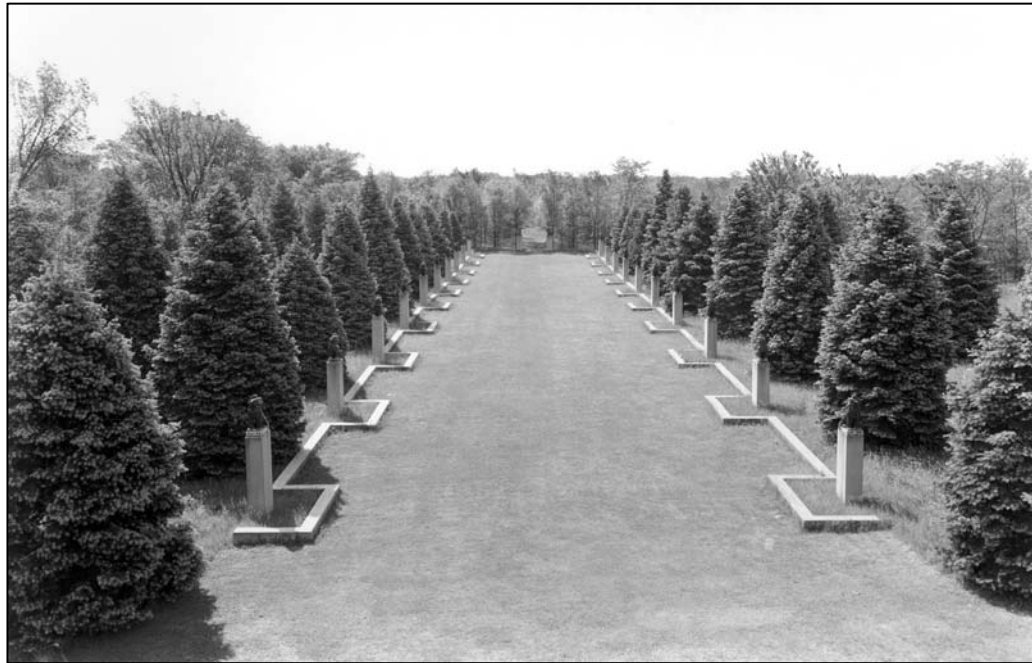
1944 (HGFG-8) This view shows little change since 1937 other than the growth of trees. Note that central turf panel is mowed, while grass is longer behind the curbing.

Images HGFG 8 and 10, taken in 1944 and 1951 respectively, show the intended effect of the garden, with the sunlit *Fu Dogs* backed by rows of specimen fir trees. In the intervening years the firs have grown out of scale, obscuring the *Fu Dogs*, which were meant to be the focal point of the garden, and destroying the formality of the space, as the firs have lost their pyramidal shape or been removed. Preservation is the recommended treatment, except for the plantings, which should be replaced to re-establish the intended design.

Firs behind *Fu Dogs* have grown out of scale and are dominating the space rather than serving as a backdrop for the sculptures. They should be removed and replanted. This could happen all at once or could be phased to minimize the visual impact. Phasing could be accomplished as follows: prune back woods as recommended above and prune fir limbs that directly overhang *Fu Dogs*; remove outside row of firs and plant new outside row; remove inside rows of fir at such time that most are lost and replant with white fir. Replant white narcissus, wild white daisies, and wild pinks, which are documented on 1948 plant list.

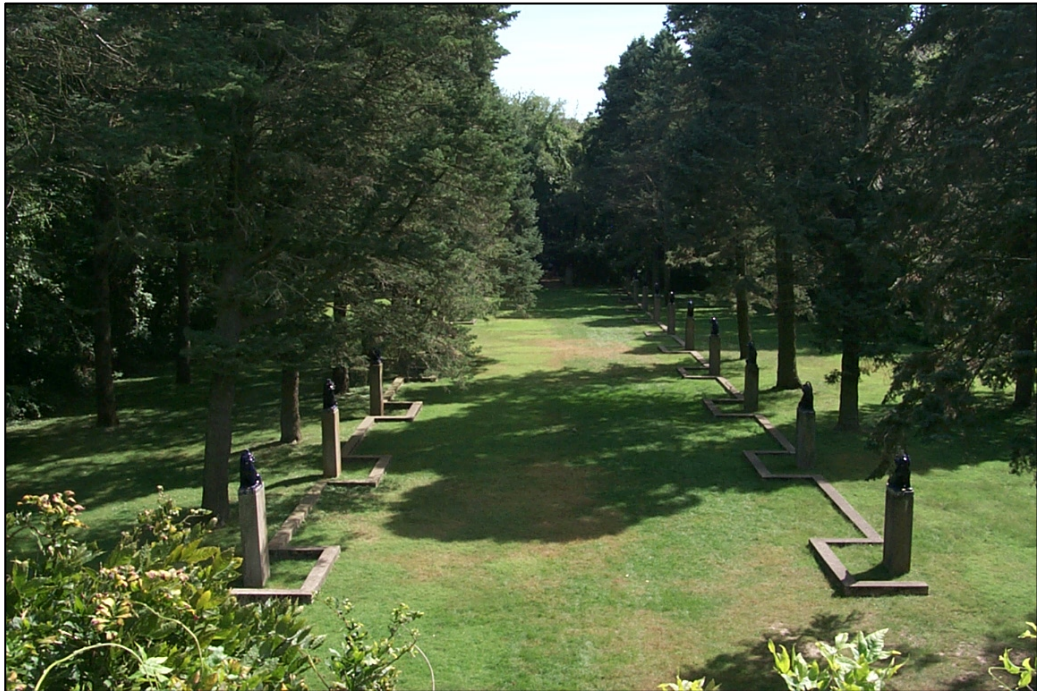
**2001** – This current view shows the extent to which the plantings have grown out of scale. Compare with earlier views taken from the House of the Golden Buddhas.

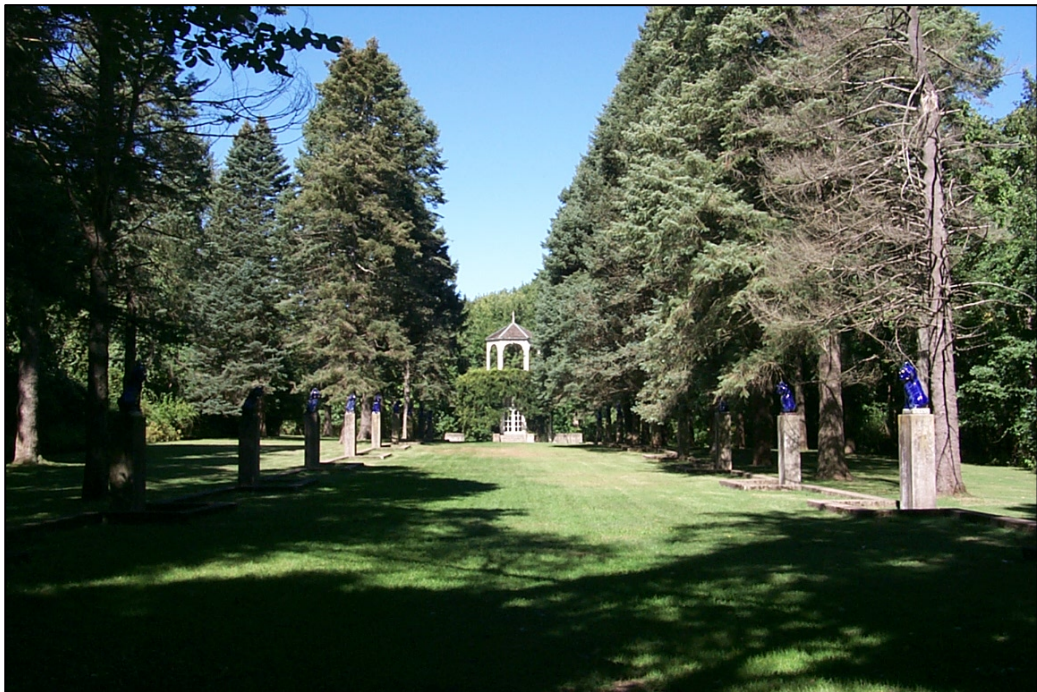
**2001** – The Fu Dogs now appear in shade and are overshadowed by the white firs lining the garden. House of the Golden Buddhas is visible in the background.

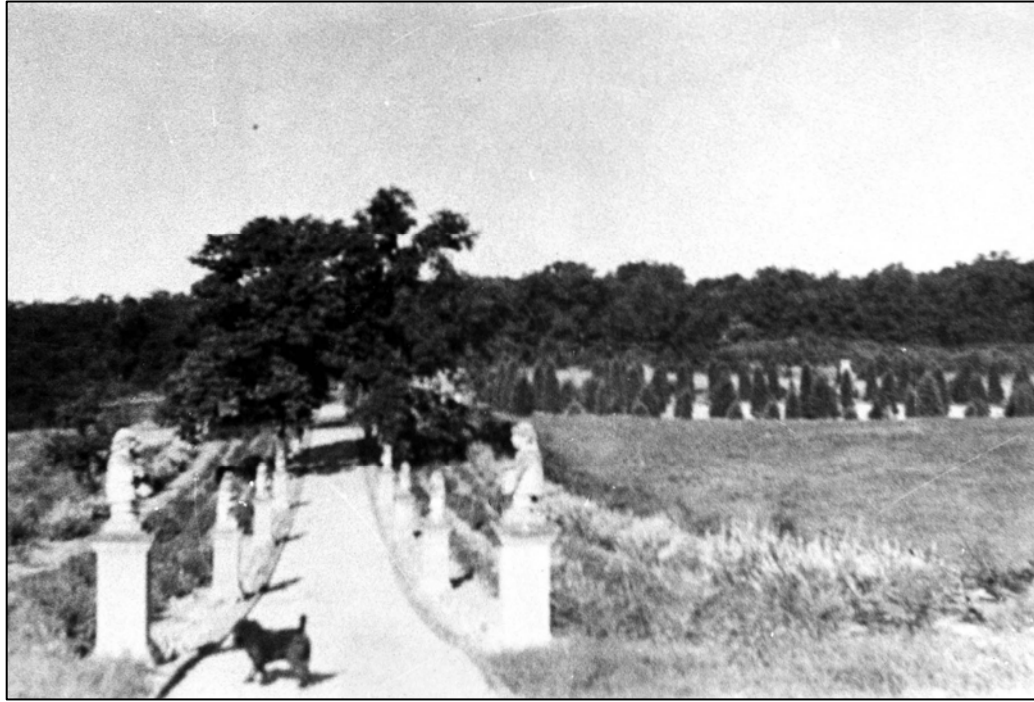
1938 (HGL-10) Early (west) view showing the *Chinese Musicians* lining the pathway and the openness of the surrounding former pasture. Note the mature forest in the background.

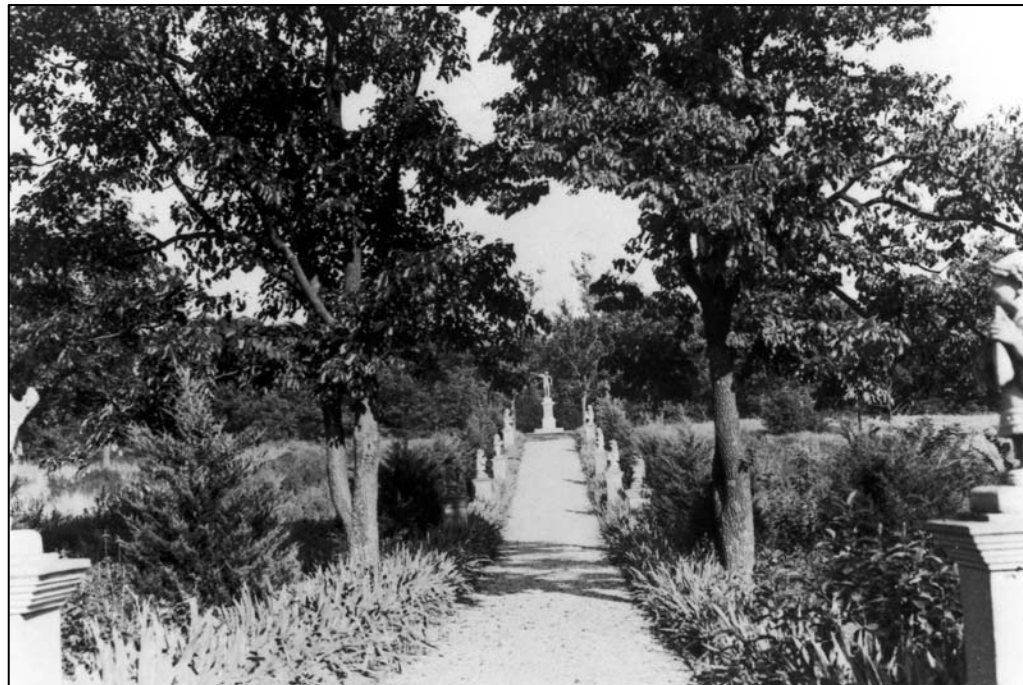
1937 (HGL-14) Another early (east) view showing plantings lining the pathway. Note the young succession field in the background.

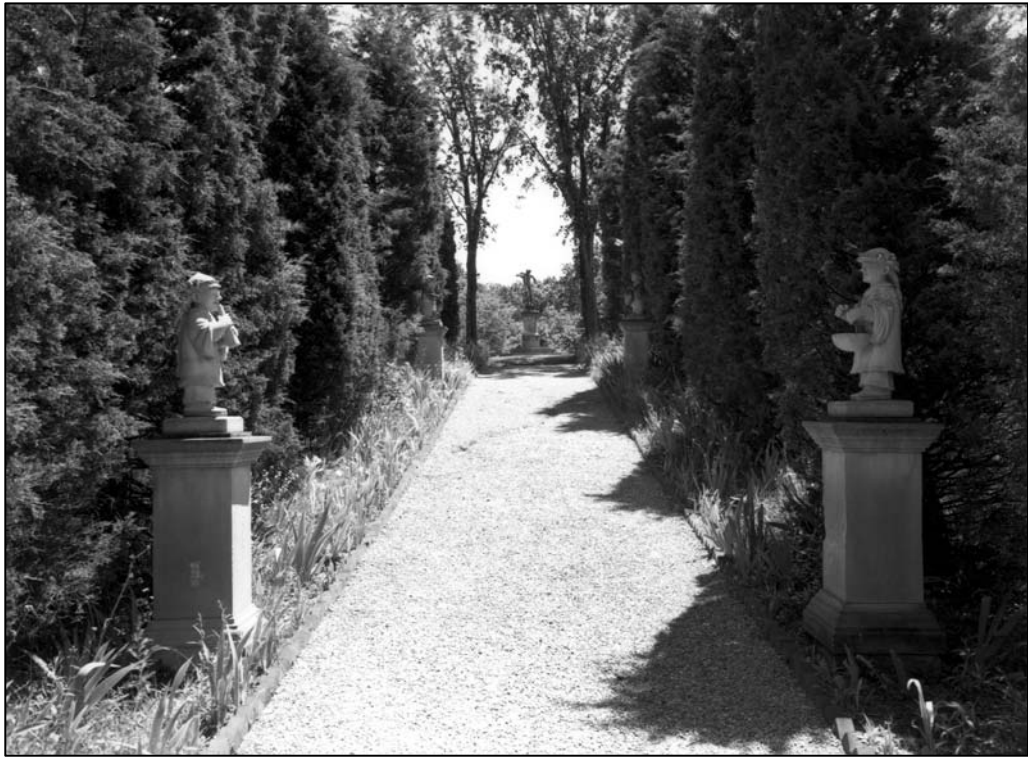
1944 (HGL-26) By this the time the vegetation had matured, creating a more enclosed space.

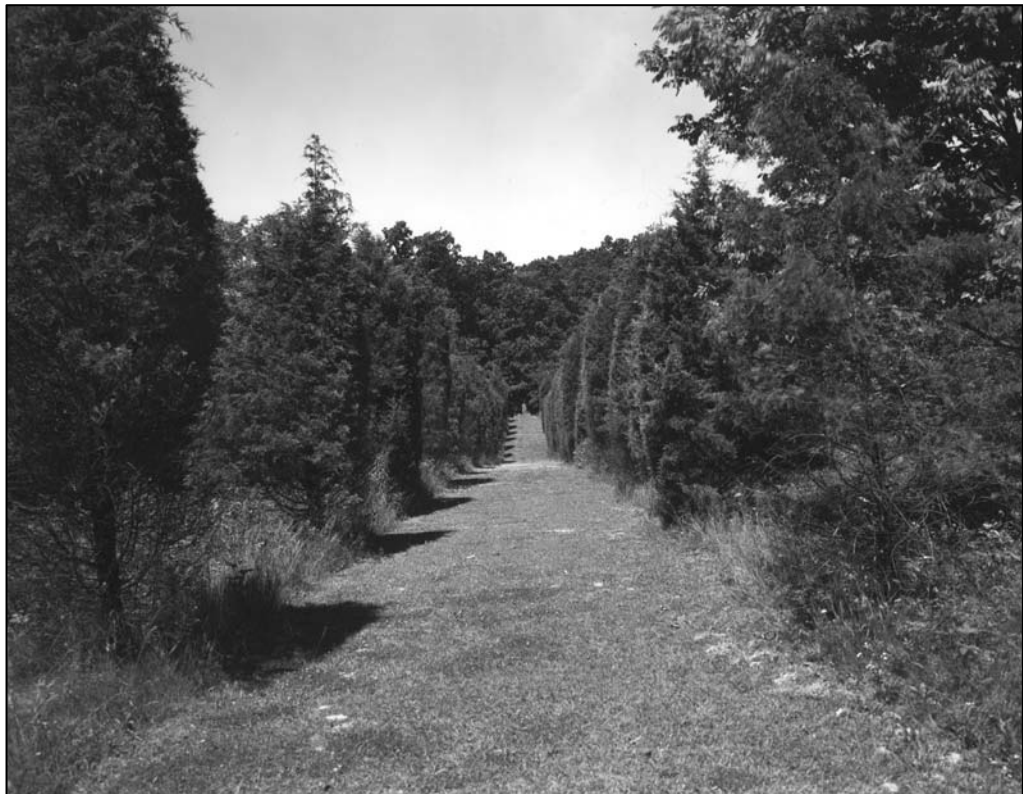
1944 (HGL-29) This view shows the cedar-lined pathway, the primary feature that remains today.

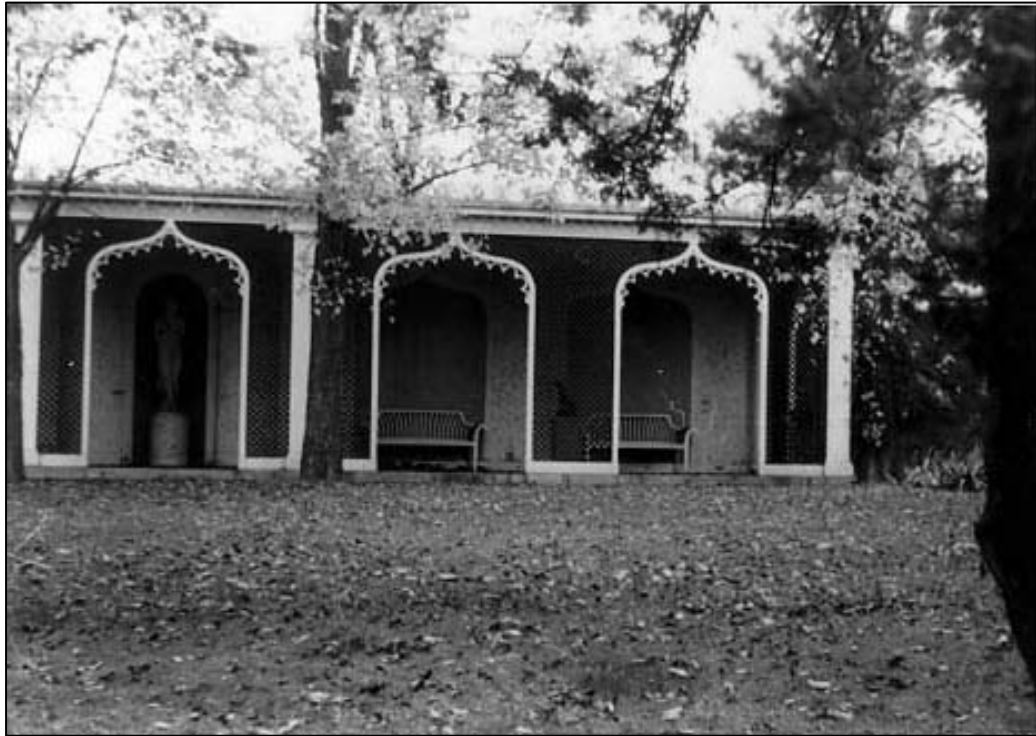
1940 (HGL-23) Detail of teahouse.

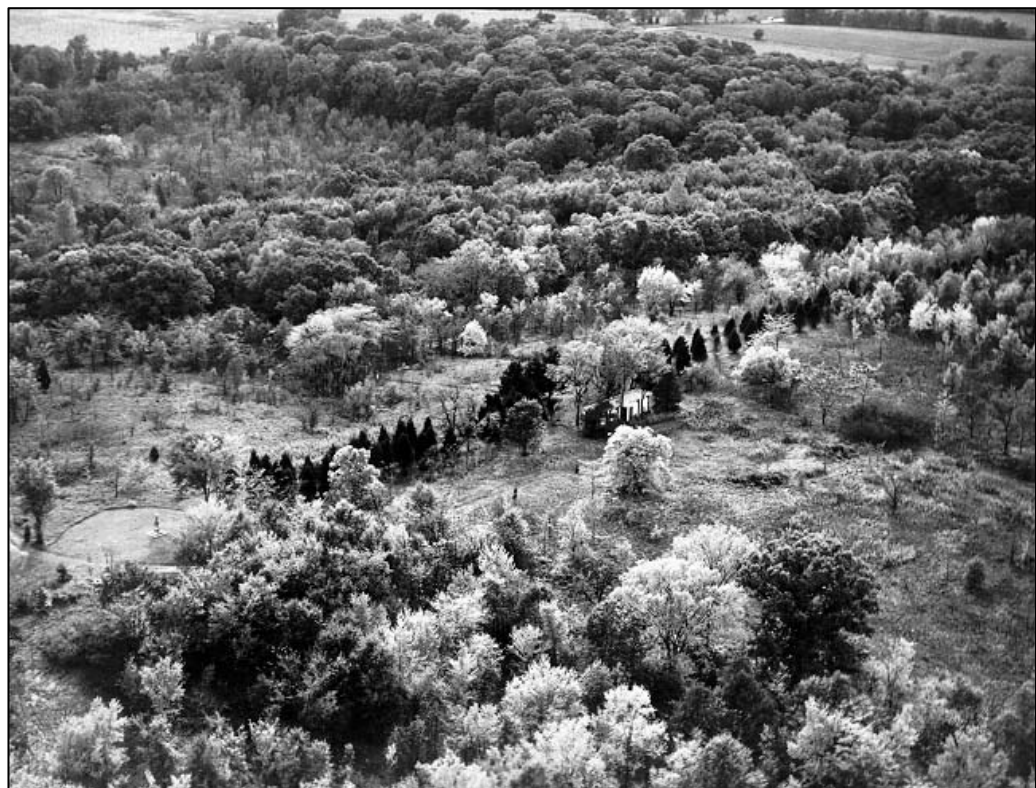
1944 (HGL-24) This aerial view shows the extent to which the pasture surrounding the Lost Garden had become overgrown by the time the property was transferred to the University. Dark cedars and the teahouse are visible near the center of the picture.

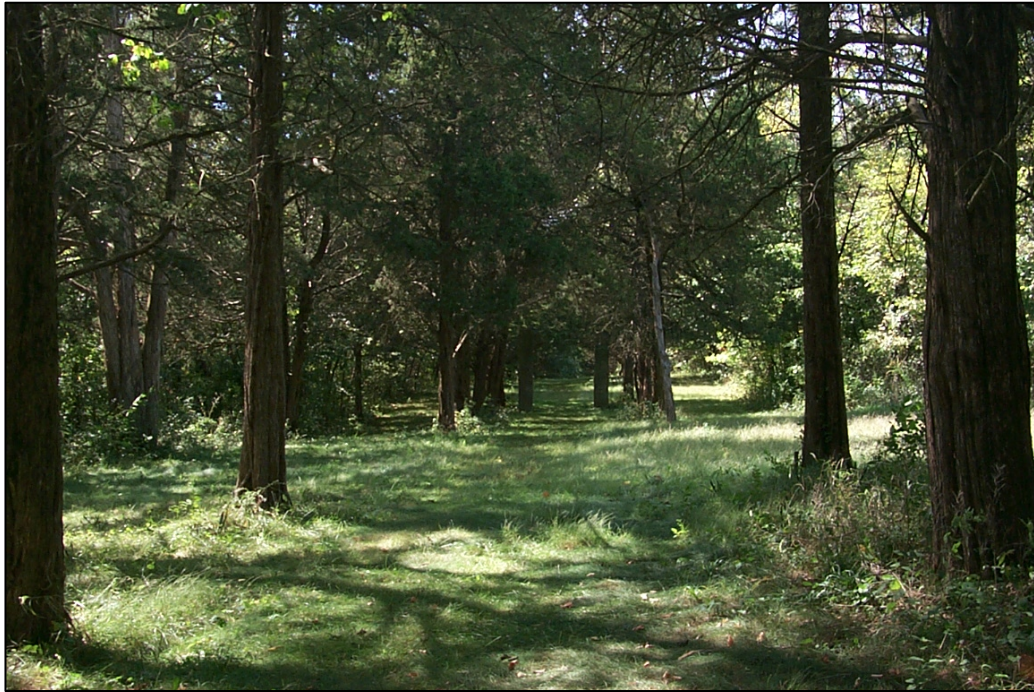
Fall 2000 View along main pathway of Lost Garden showing remnant cedar allée.

Remove deadwood and weak, leaning or hazardous trees in allée regularly. Retain healthy trees. Prune edges periodically to prevent narrowing of corridor. Mow grass periodically during growing season.

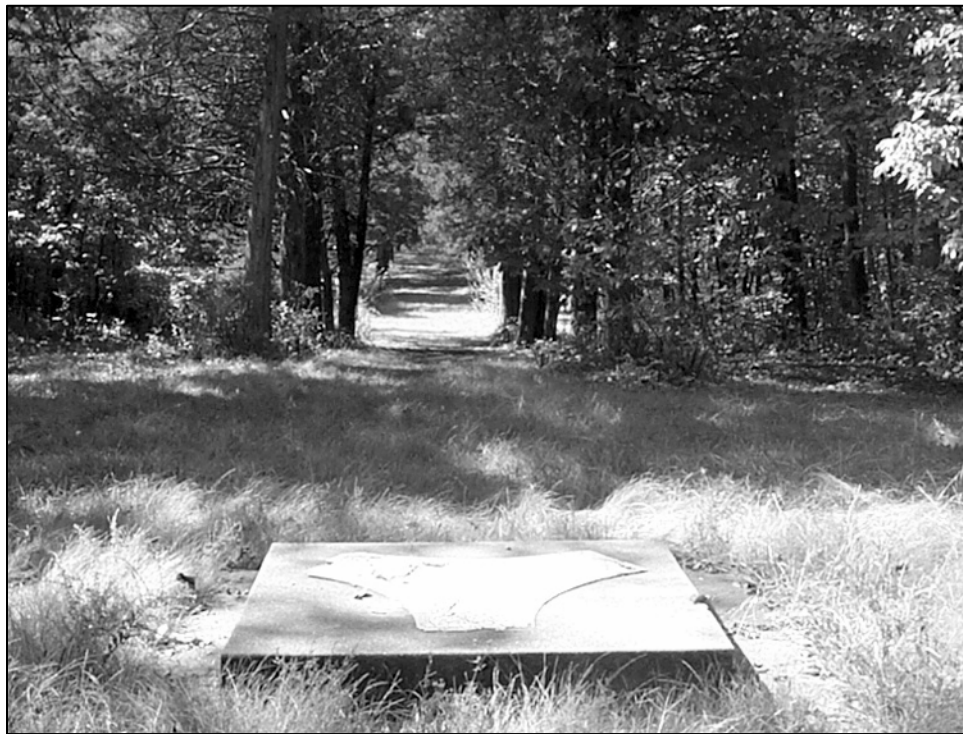
Fall 2000 View looking west towards Lost Garden with sculpture platform for *Three Graces* in the foreground.

Inspect columns and other structures regularly to assure that they are structurally sound and do not present a hazard.
